Conservation and Management Plan

Reilig Ospidéal Naomh Lomáin

St Loman's Cemetery

Mullingar Co. Westmeath

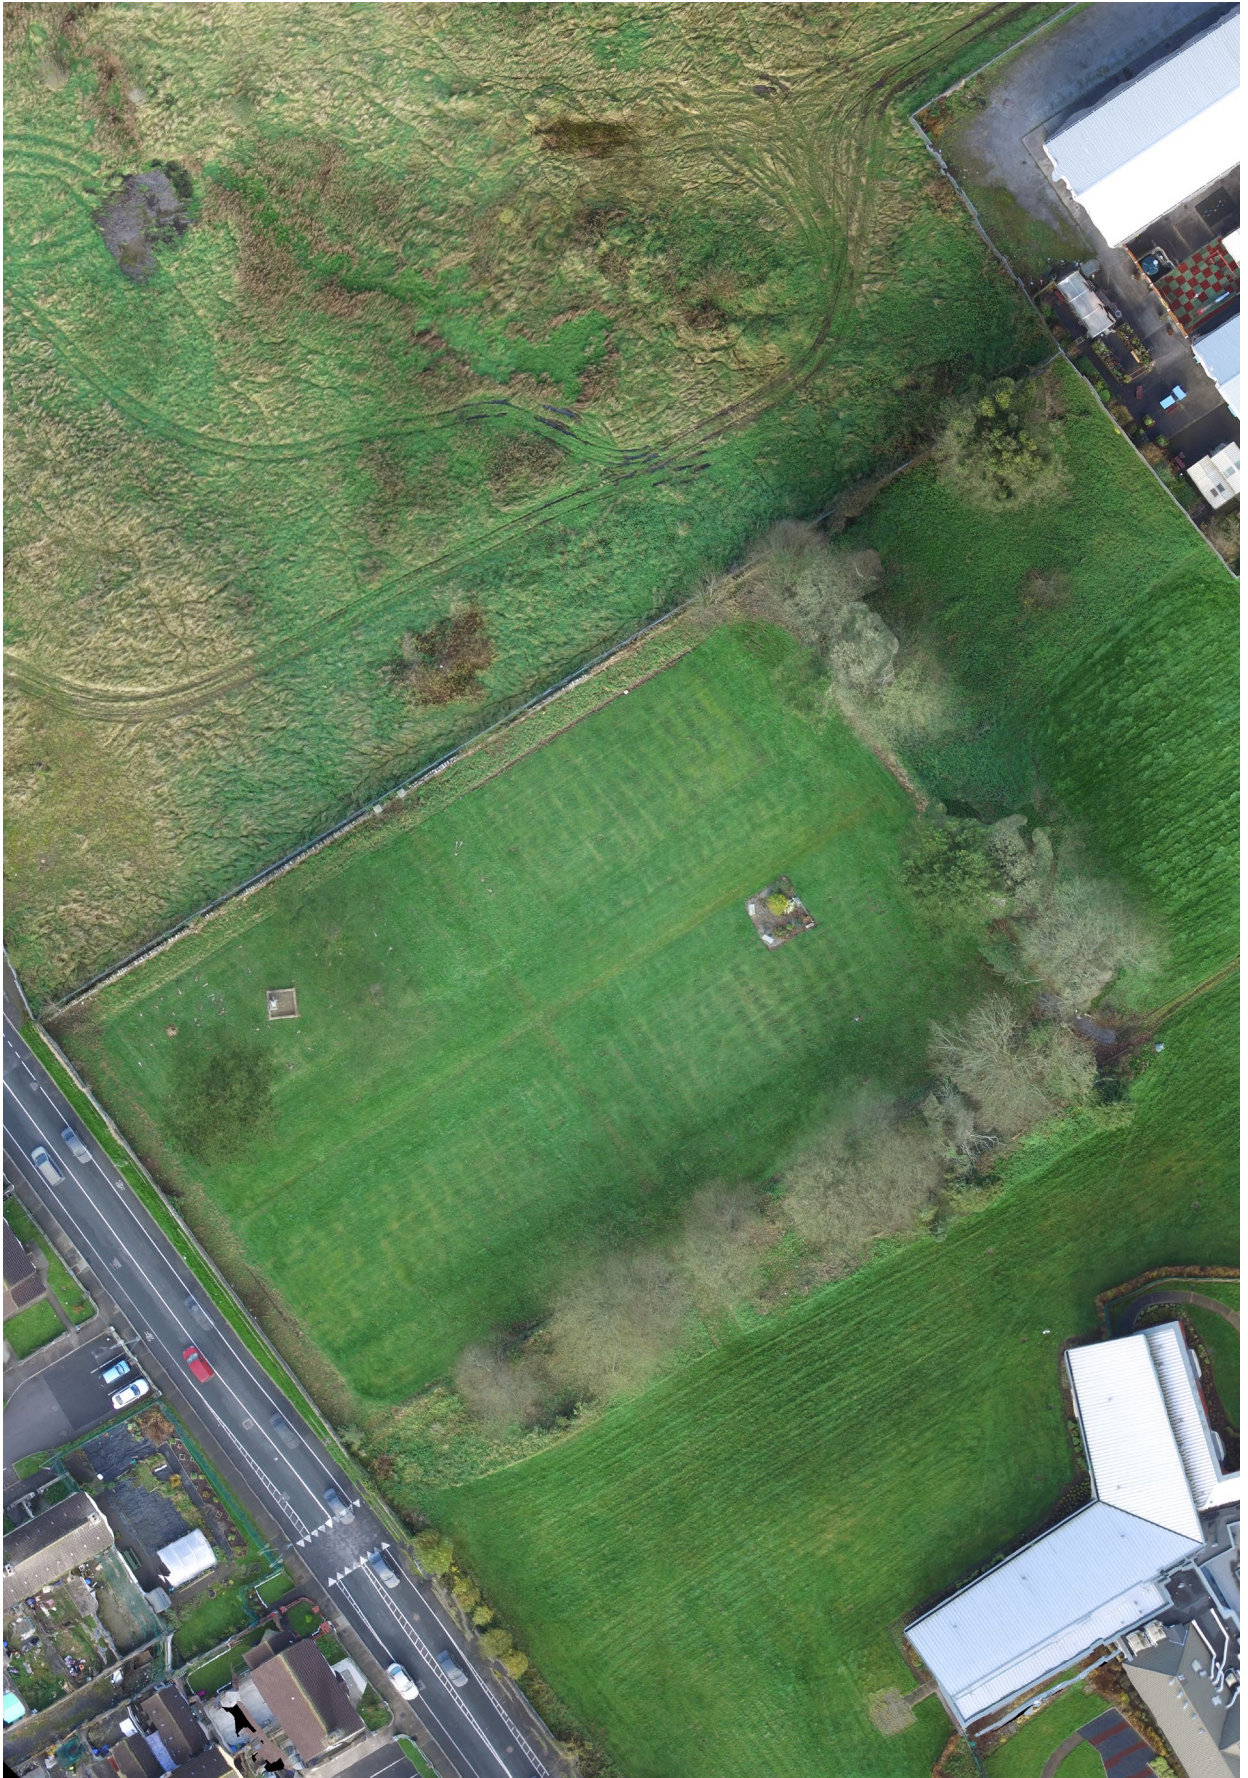
Plate 1: Aerial view of St Loman's cemetery.

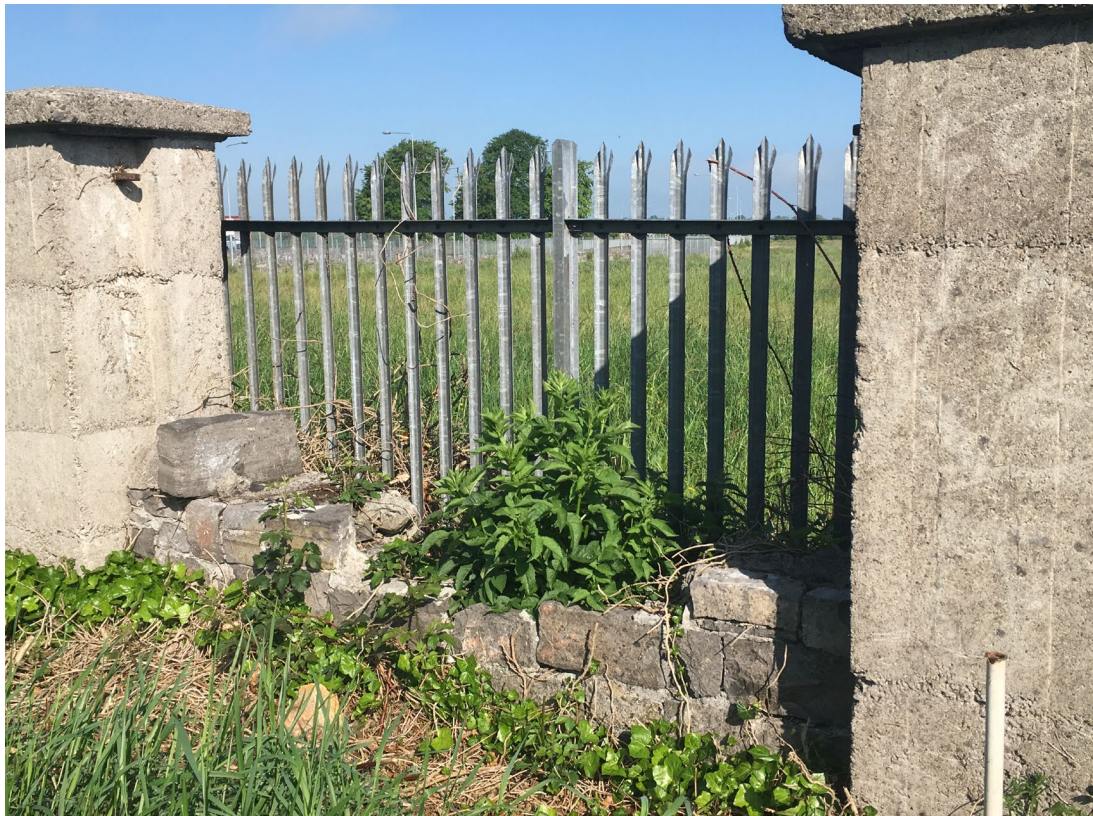
Plate 6: The original N gate entrance to the cemetery. Gate piers are mass concrete built.

A security fence has been erected outside the N boundary wall. The original N gate consists of two monumental mass concrete piers and the original iron gate is missing. The gateway is blocked by a low limestone rubble wall (**Plate 6**). An inner face recess in the piers shows where an iron gate was originally hanging and opening inwards. If the external security fence remains in place there no need to reinstate an iron gate in this gateway. The rubble wall filling the gateway should be repaired along with the partly-collapsed section of the N wall.

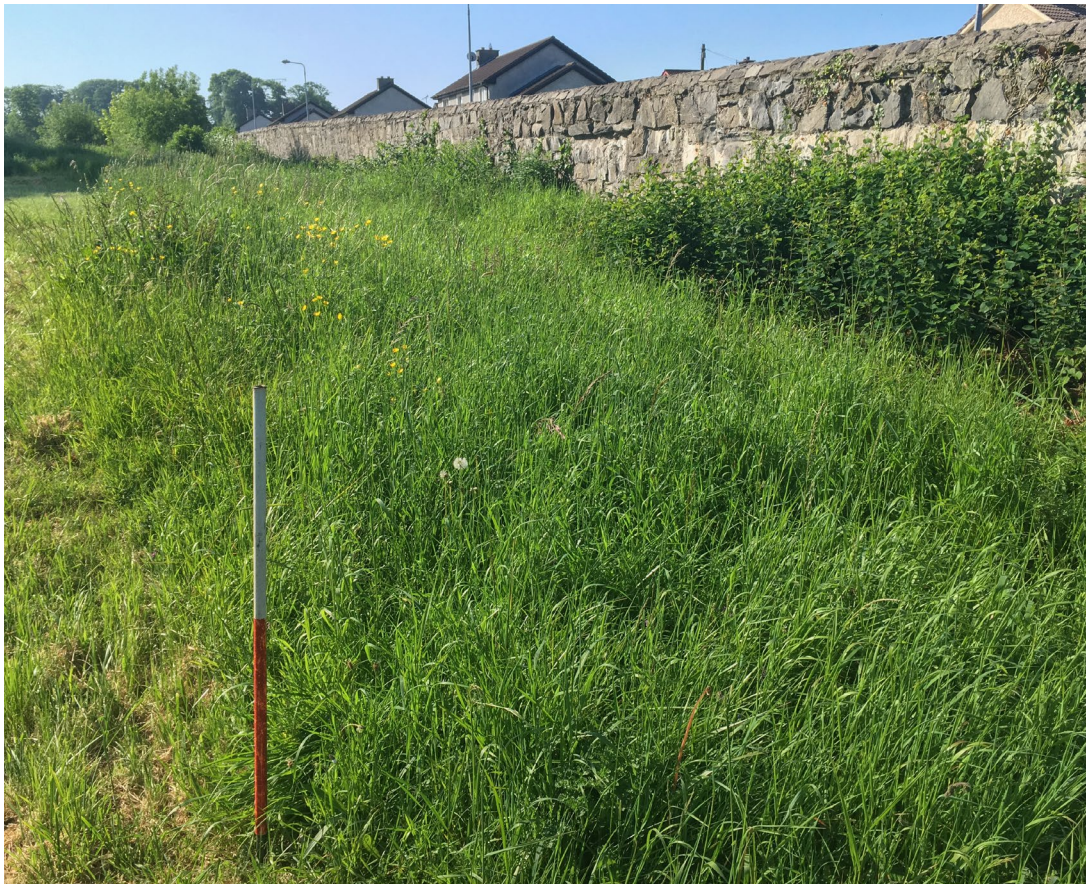
Plate 7: Photograph taken in 2017 of the cemetery west wall & Plot 12. The top courses of the wall were added in 2005/6 when the wall was largely rebuilt following severe damage caused by vandalism. Plot 12 was strimmed and raked in 2016

The W boundary wall is built of rough coursed limestone blocks of 8-12 courses in height. The N boundary wall is only four courses high with a crenellated top. Both walls have been considerably repaired in the last 20 years having previously suffered considerable collapse in places (**Plate 7**).

The W wall is in a good condition and has been extended upwards probably in 2005/6 when the Robinstown road was constructed. The 2005/6 works also involved significant repair of the W wall. A photographic survey from the mid 1990s shows the W wall in very poor condition with multiple breaches, some to ground level. There are a number of

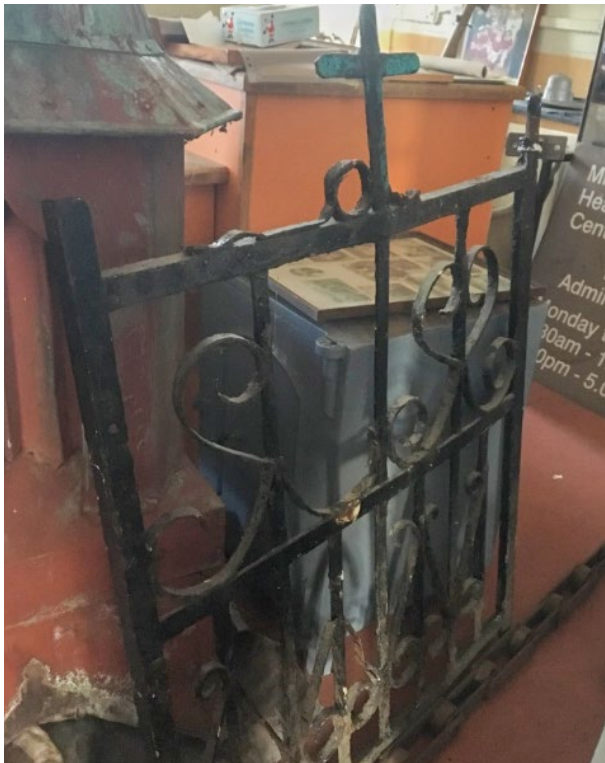
Plate 9: Wrought iron gate from the later SE corner entrance. Possibly made within St. Loman's Hospital. Should be repaired and re-erected

A later gateway in the SE corner (**Plate 13**) of the cemetery was added and this is the current main access way as it is closest to the car park. A wrought iron gate originally closed the gap but was removed and is kept in an informal hospital museum/store. This gate should be repaired and re-erected.

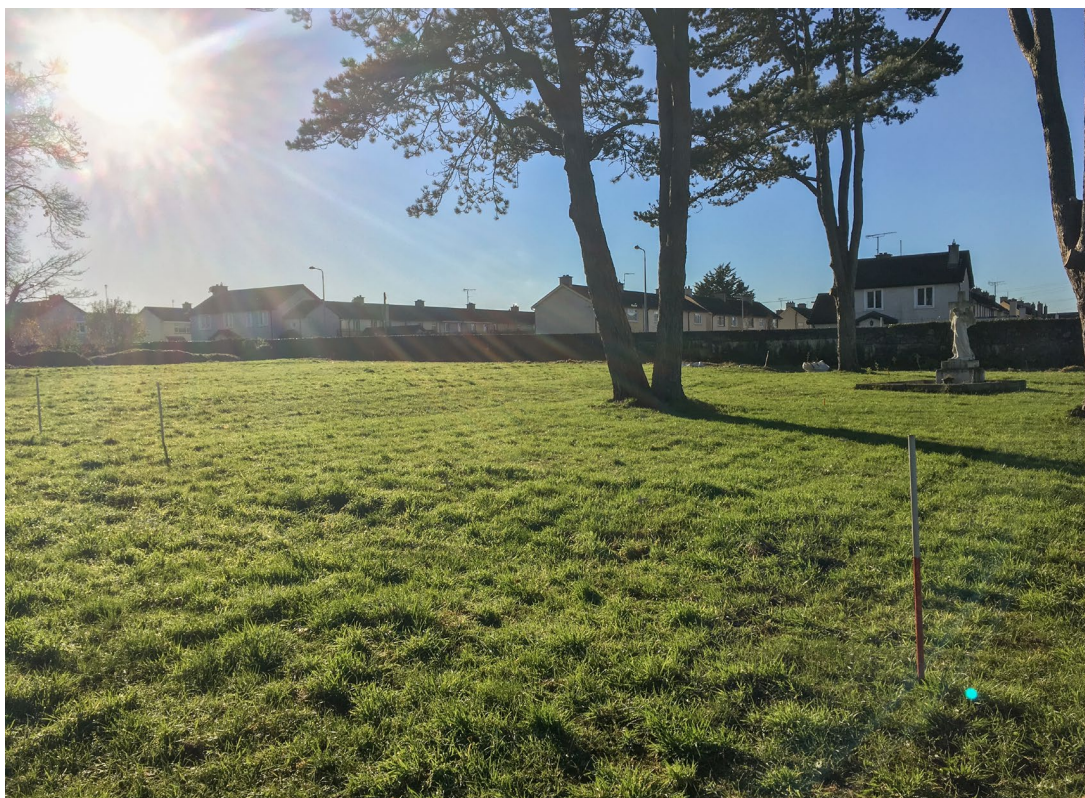
Plate 10: View of Plot 4 from NE - ranging rods show the edges of the burial plots and two of the original internal paths, now grown over.

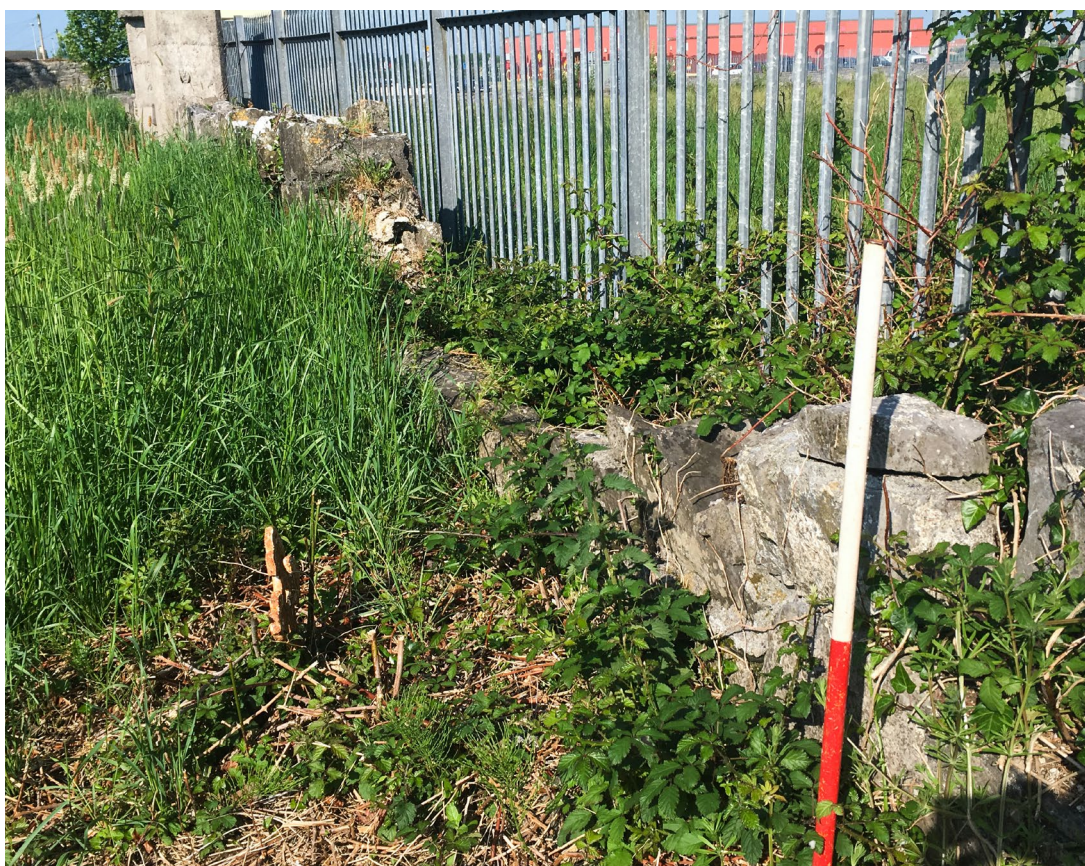
Plate 11: View of damaged section of N wall W of Gate

The N boundary wall requires further repair works with a length of approx. 33m in need of immediate repairs.

places in the W wall where lime mortar is missing and needs to be replaced. The N wall is presently in poor condition in a number of places and needs to be repaired with topmost courses and crenellated top replaced (a length of 33 m of wall requires repair) (Plates 11 & 12).

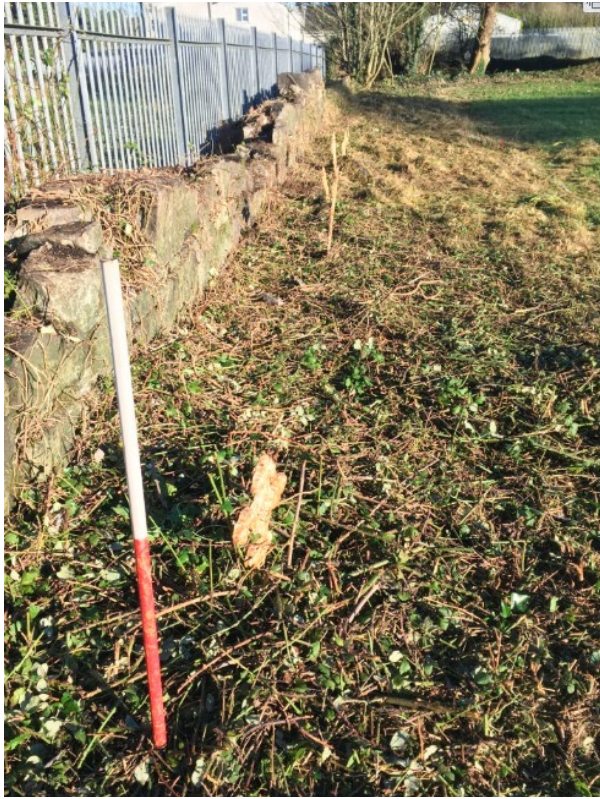
Plate 12: View of damaged section (22m in length) of N wall E of Gate; also showing burial plot 2

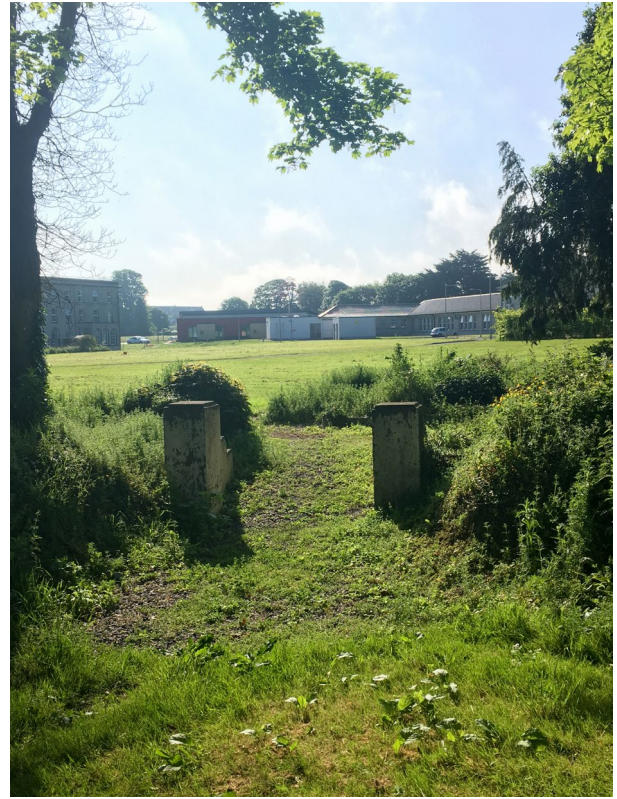
Plate 13: Photograph of the current SE entrance to the cemetery with concrete block built gate piers and overhanging branches.

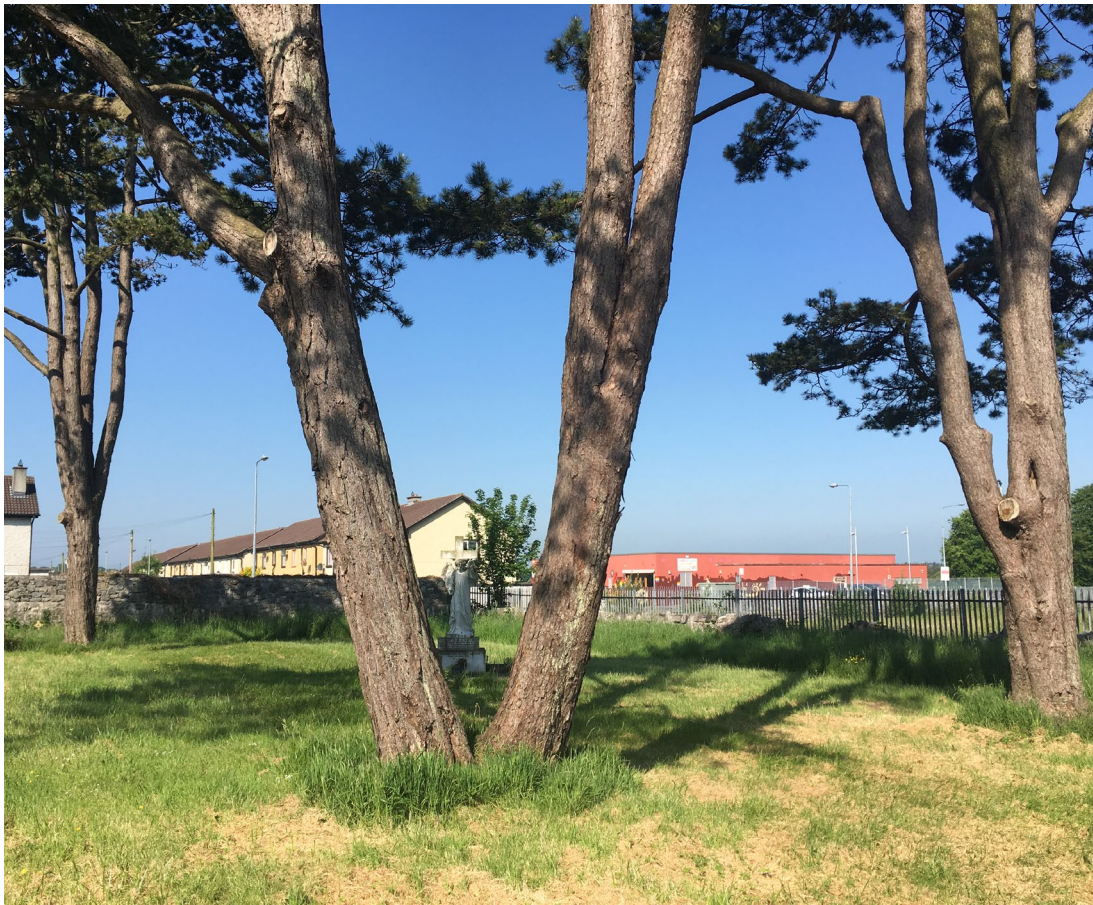
Plate 14: Plot 4 the Austrian Pines believed to have been planted approx 1910. The Finegan monument is visible between the cleft in the tree

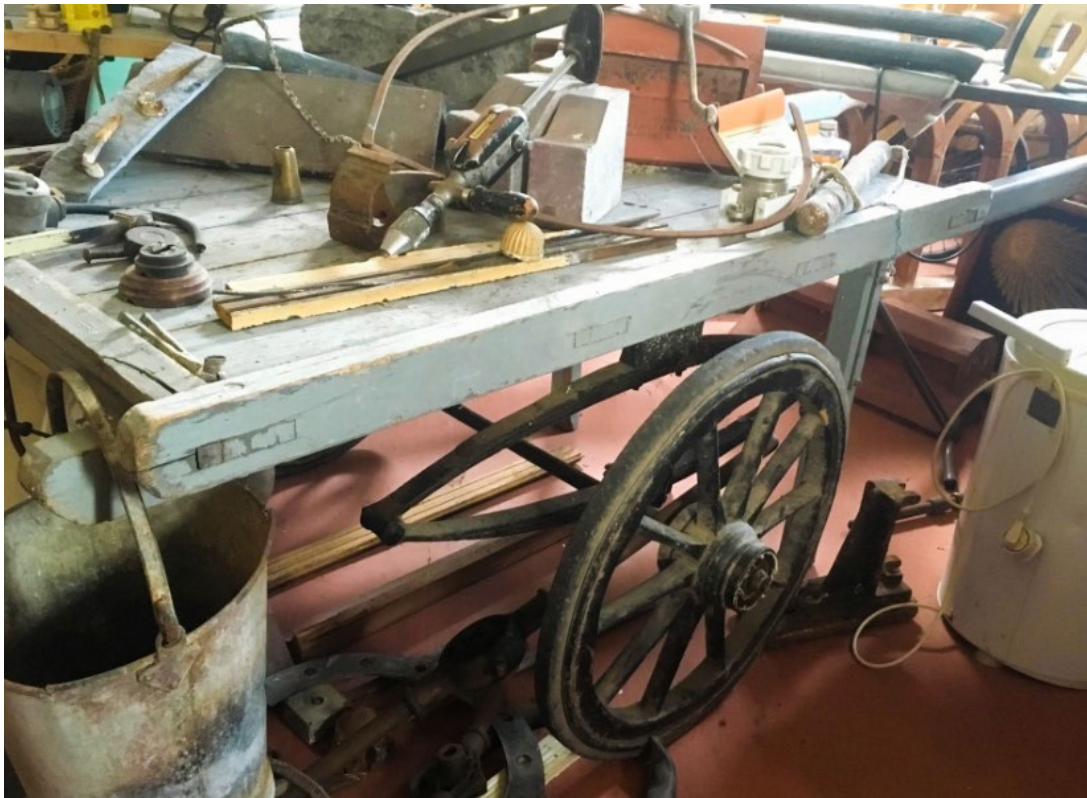
Plate 18: Wooden cart with rubber wheels of the type probably used to carry coffins around the hospital grounds. This cart is kept in a store in the hospital

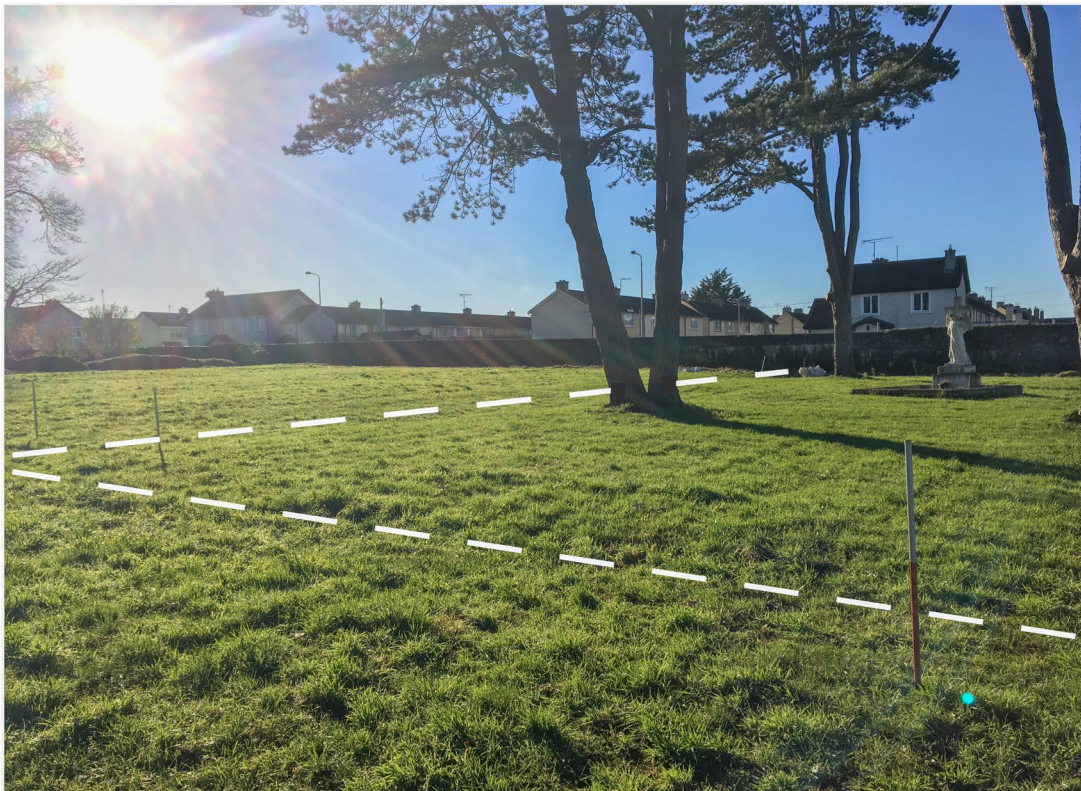
Plate 19: View of Plot 4 from NE - ranging rods show the edges of the burial plots and two of the original internal paths, now overgrown.

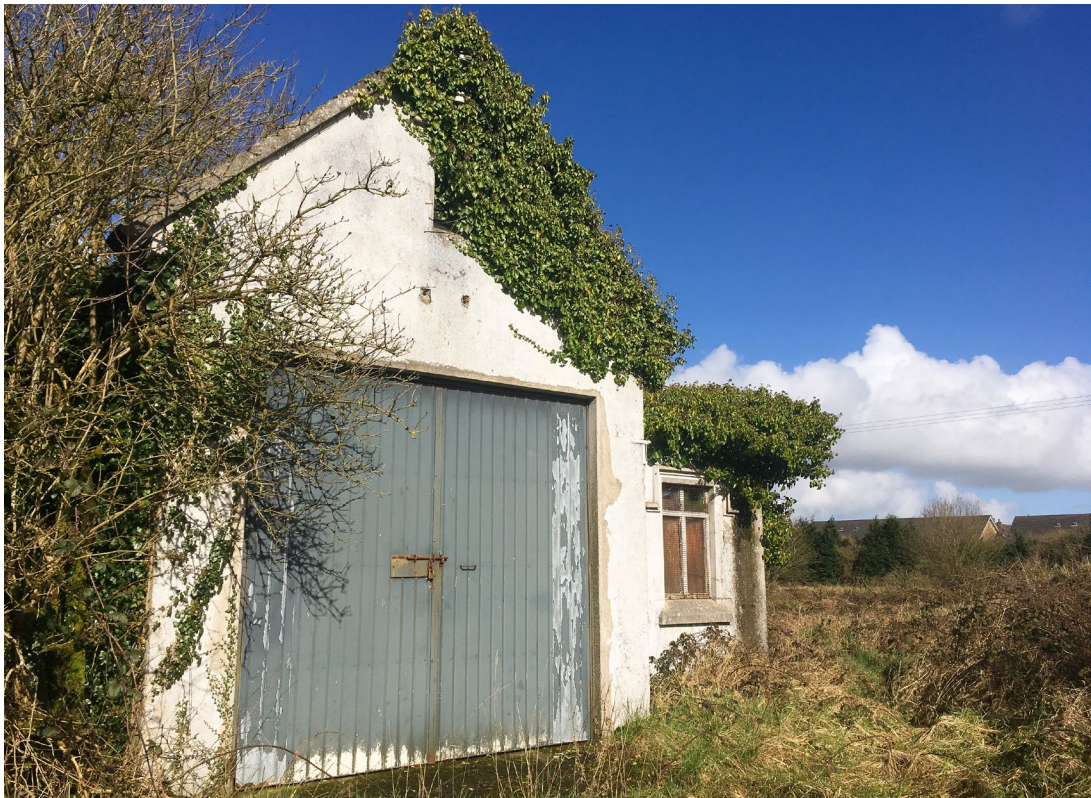
Plate 21: Photograph, taken from S, of the original hospital mortuary which was converted to a COI chapel in the 1960s.

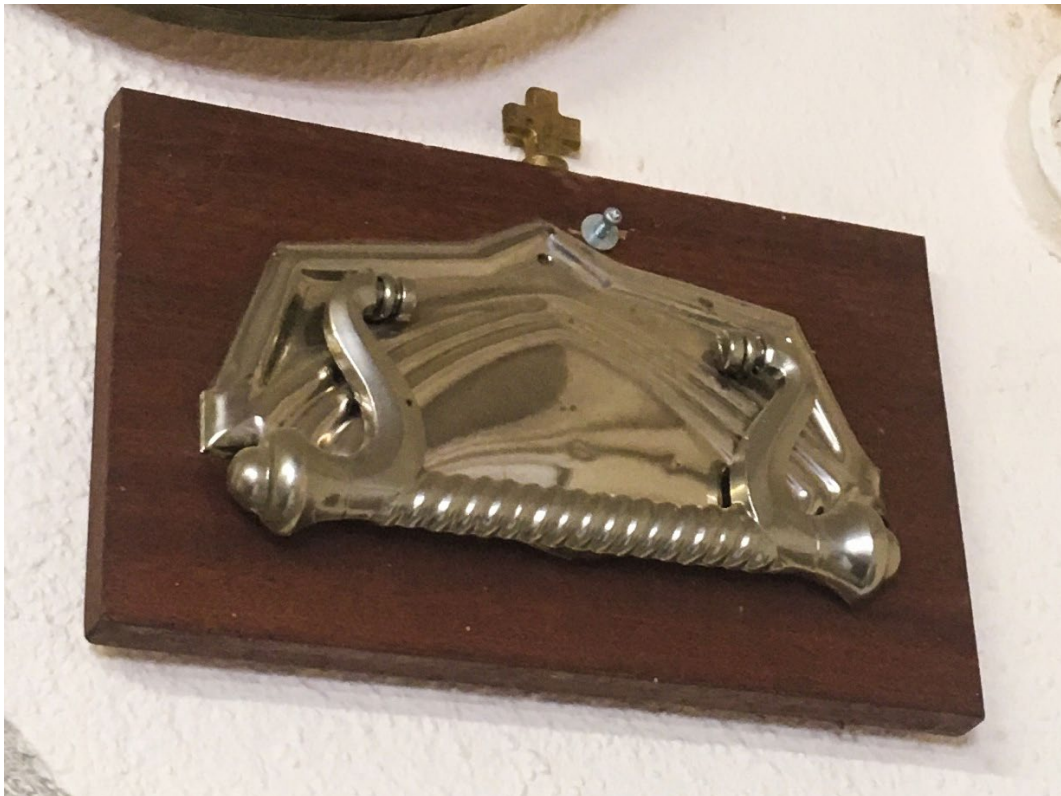
Plate 22: Coffin handle in St. Loman's carpentry workshop

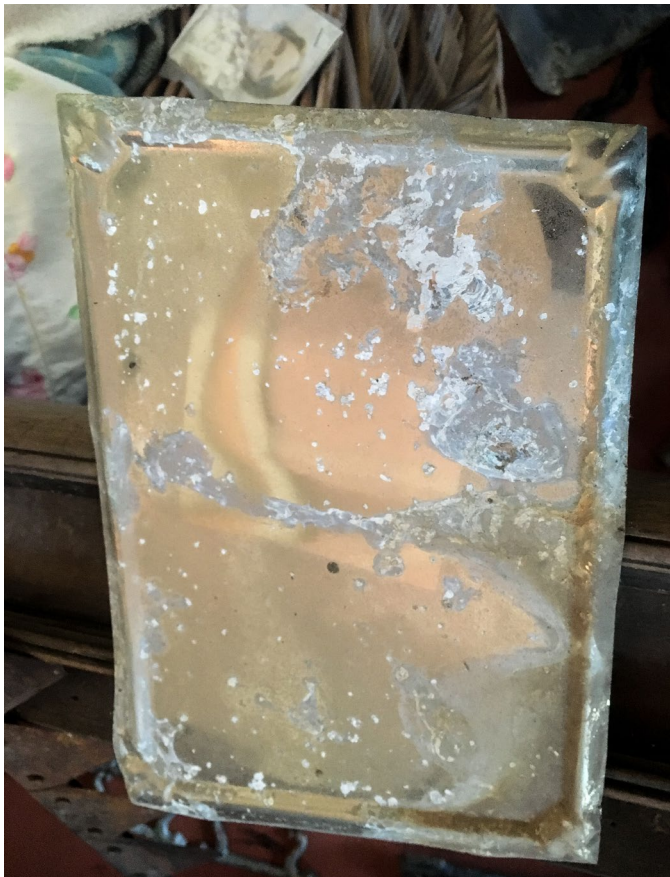
Plate 23: Unused coffin plate found in St Loman's. These were designed to have a name and date etched on (essentially handwritten) and affixed to coffin lid.

One blank coffin plate (**Plate 23**) has been found in St. Loman's Hospital. Retired staff had found the plate and some coffin handles and kept them in a hospital store. No coffin plates have been found to date in the cemetery. Coffin plates are important elements of coffin ornaments as the name of the deceased can be etched on them.

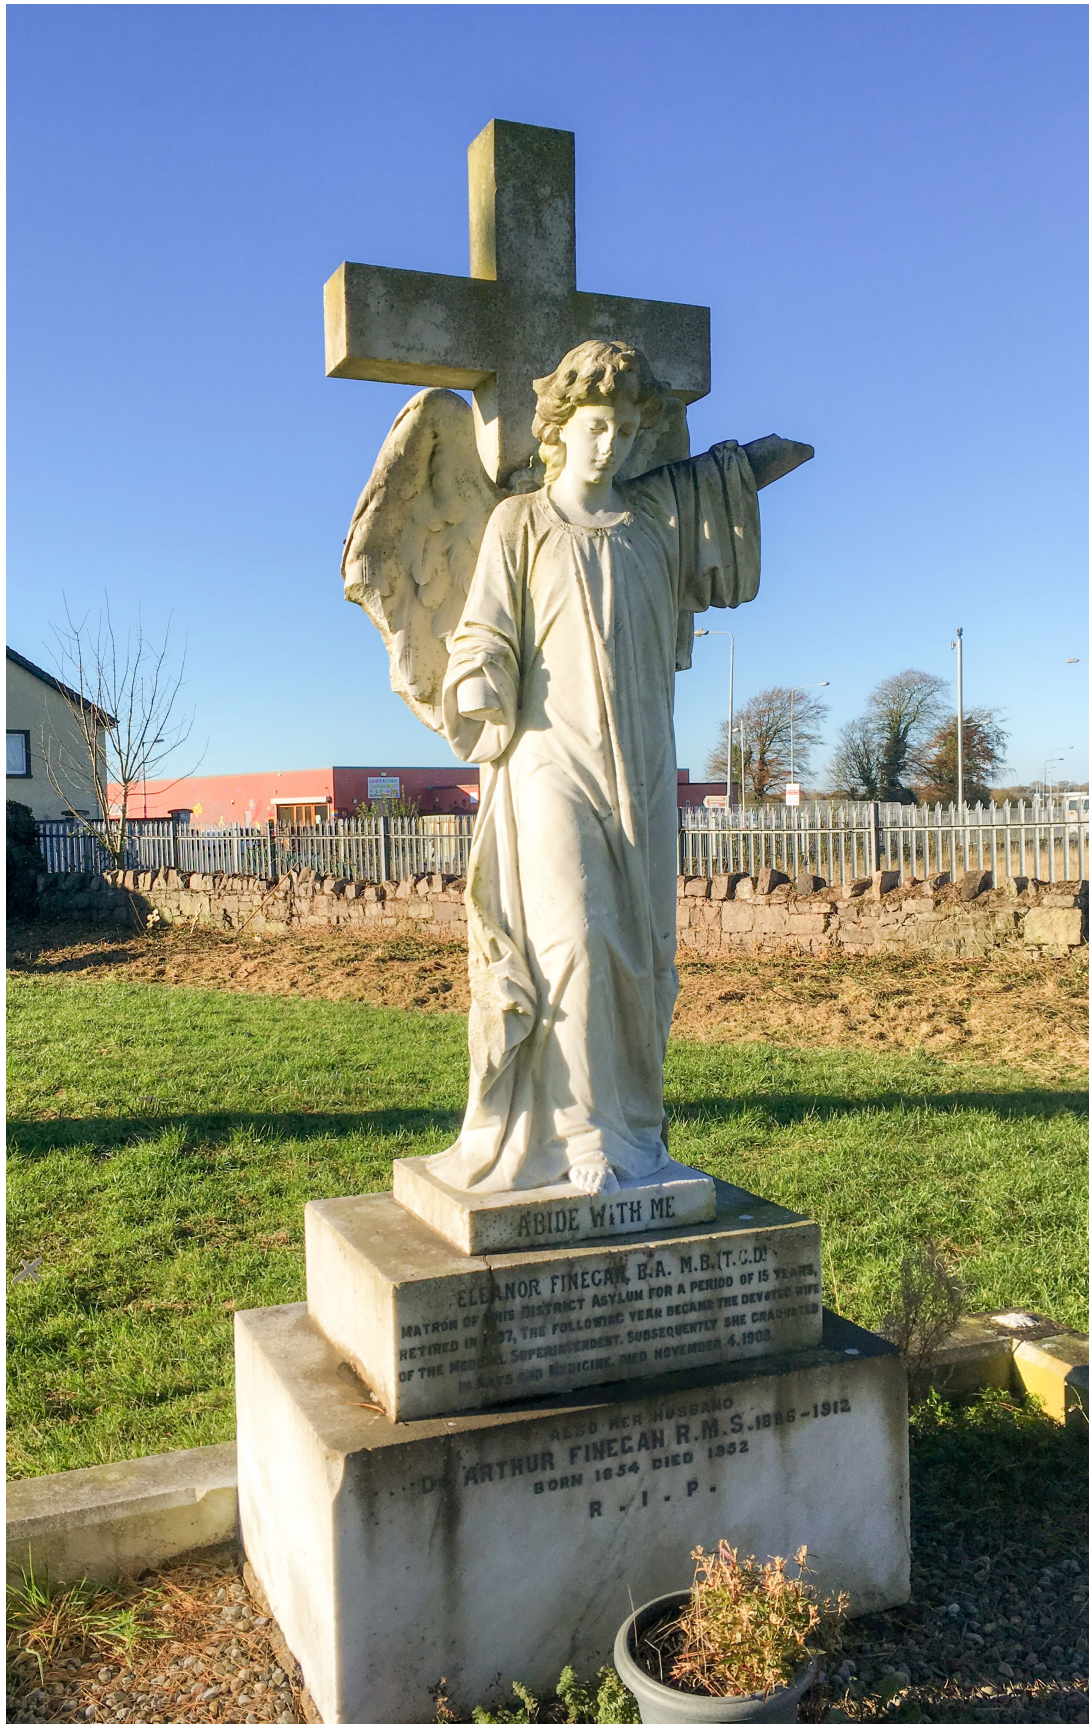
Plate 24: The Finegan Monument in Plot 4 of St. Loman's cemetery.

The white marble angel was beautifully carved but it has suffered the effects of vandalism and perhaps storm damage with the angel's wingtips and hands all being damaged as well as the angel's nose. The quality and style of the monument indicate that it was erected in the early 20th century rather than in the 1950s or 60s after Dr. Finegan died.

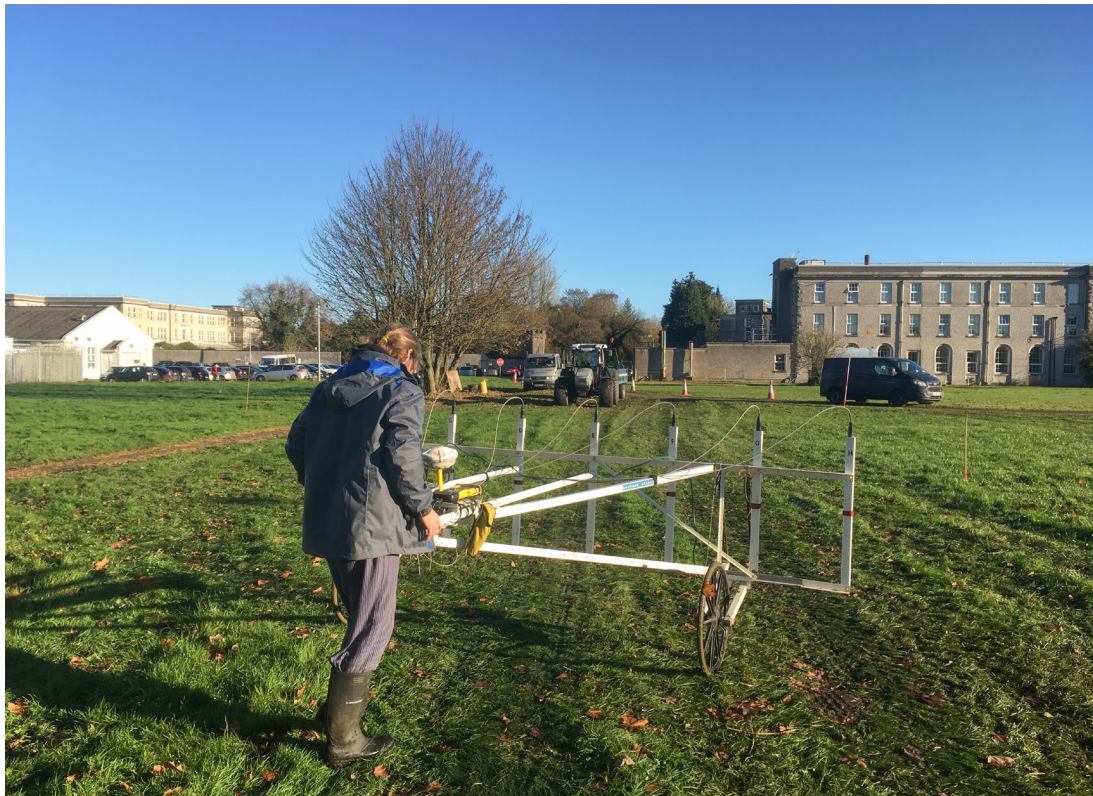
Plate 28: The geophysical survey of St. Loman's cemetery, interior and immediate exterior, in action. Photograph of Earthsound staff.

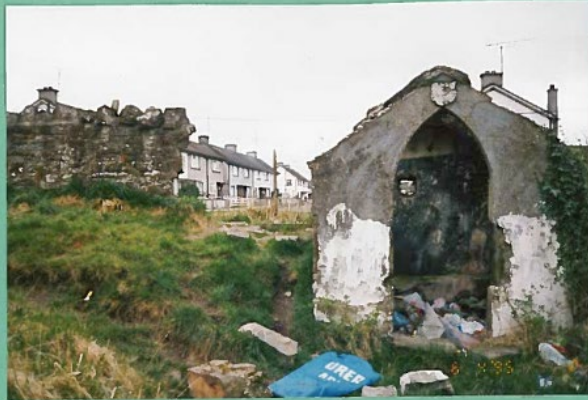
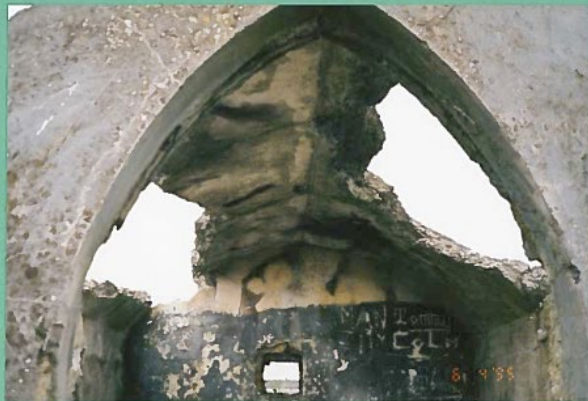
Plate 31: Mid-1990s photograph showing damage to W boundary wall and to the original mortuary within the cemetery

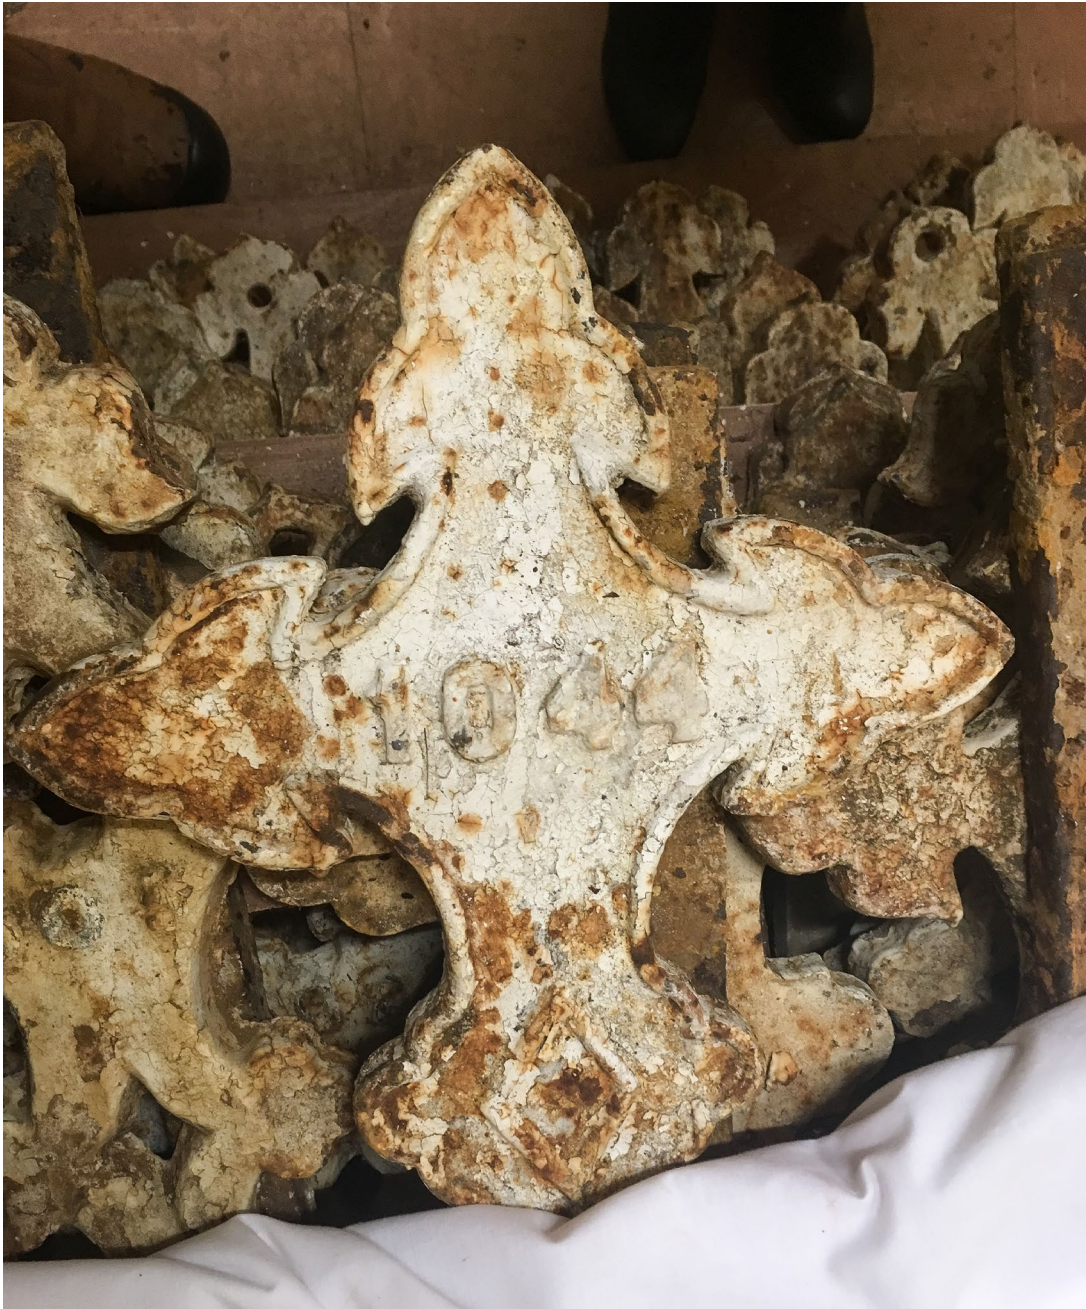
Plate 32: Type 4 -short-armed finialed cross in storage in a walled-garden shed in St. Loman's

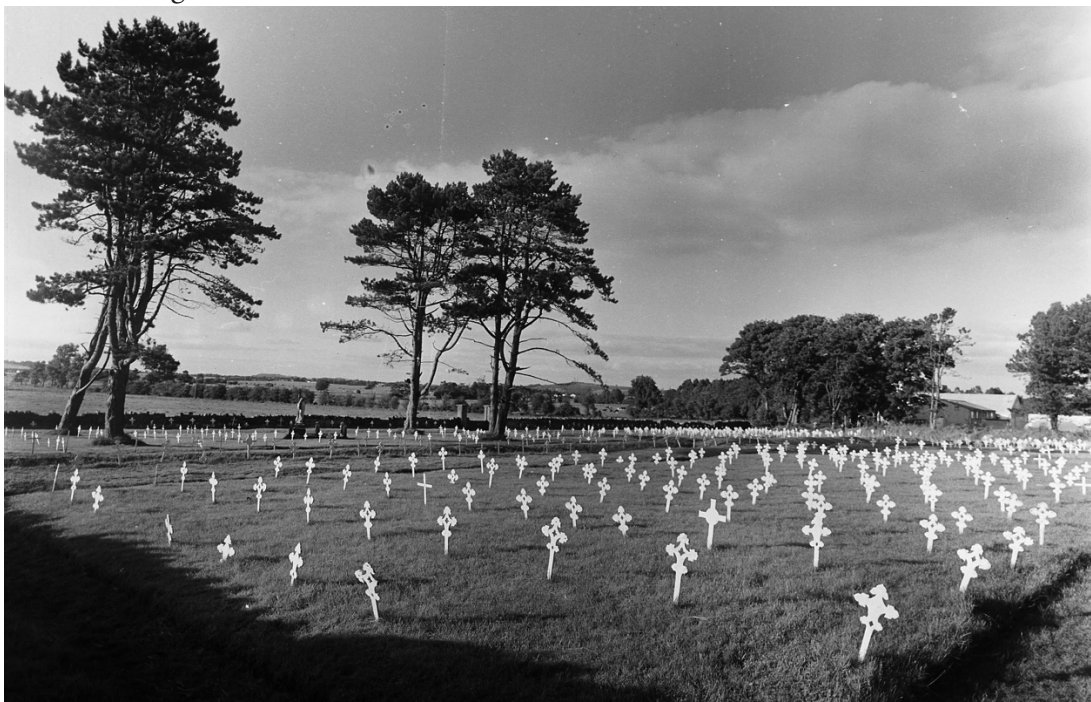
- Plots 5, 6, 7, 8 – S facing crosses are visible, spaced at regular intervals. The surface of plot 8 is
 - undulating and individual grave mounds are discernible.

- Plots 5, 7 and the E end of Plot 6 appear to have been raised with soil to an approximate height of
 - 6-700 mm above the other plots.
- Plot 10 – E facing crosses with approx. 1m intervals. Nine crosses are present in row 12, 12 crosses in row 3, and 11 crosses in row 4, indicating some variability in the width allowed for each grave.

Plate 33: Photograph from 1970s in SW corner

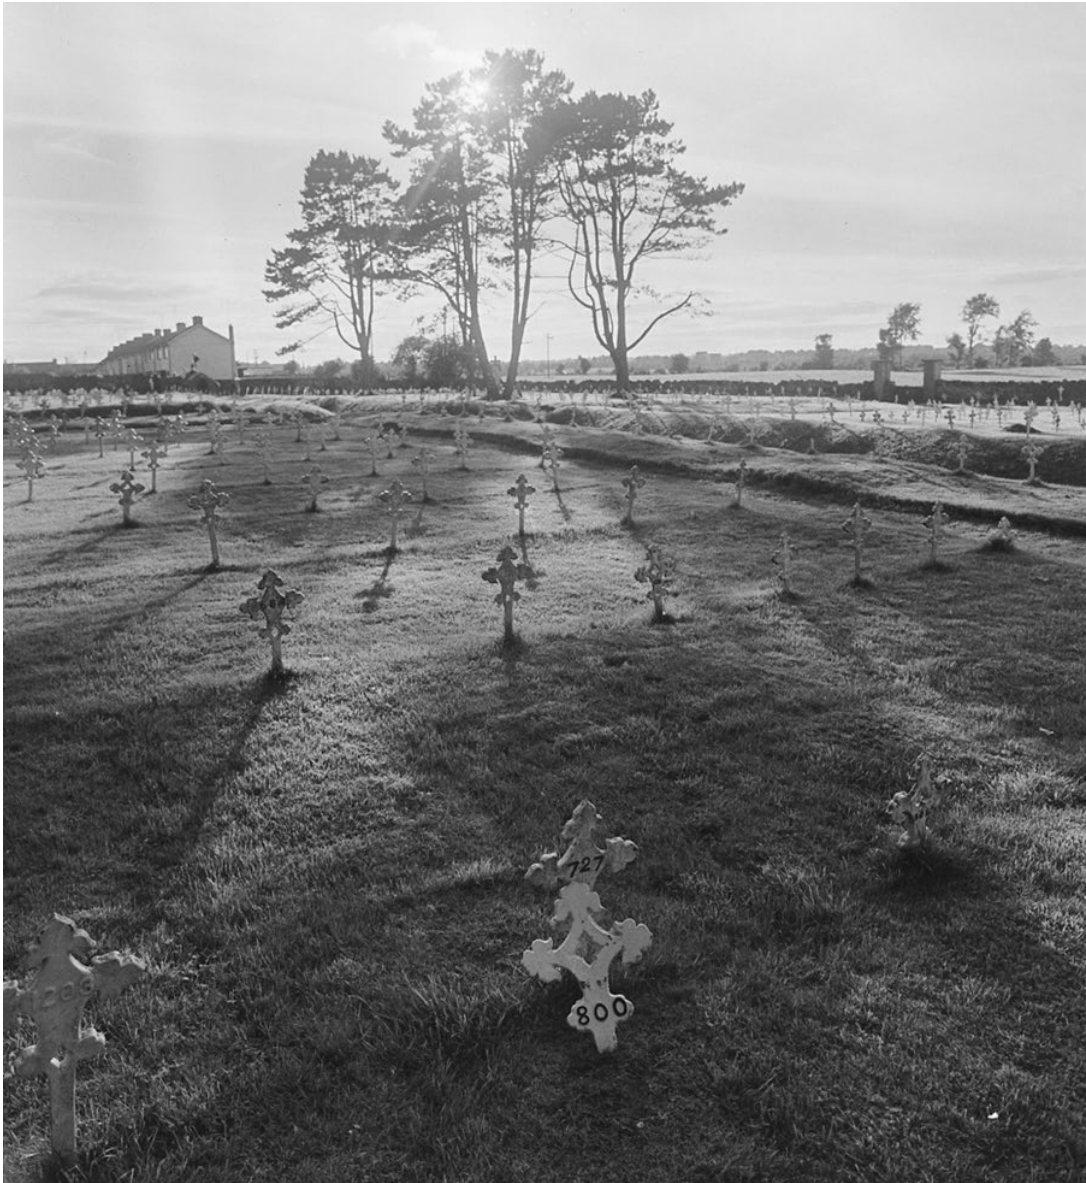
Photograph 2

Plate 34: Photograph from 1970s in SE corner

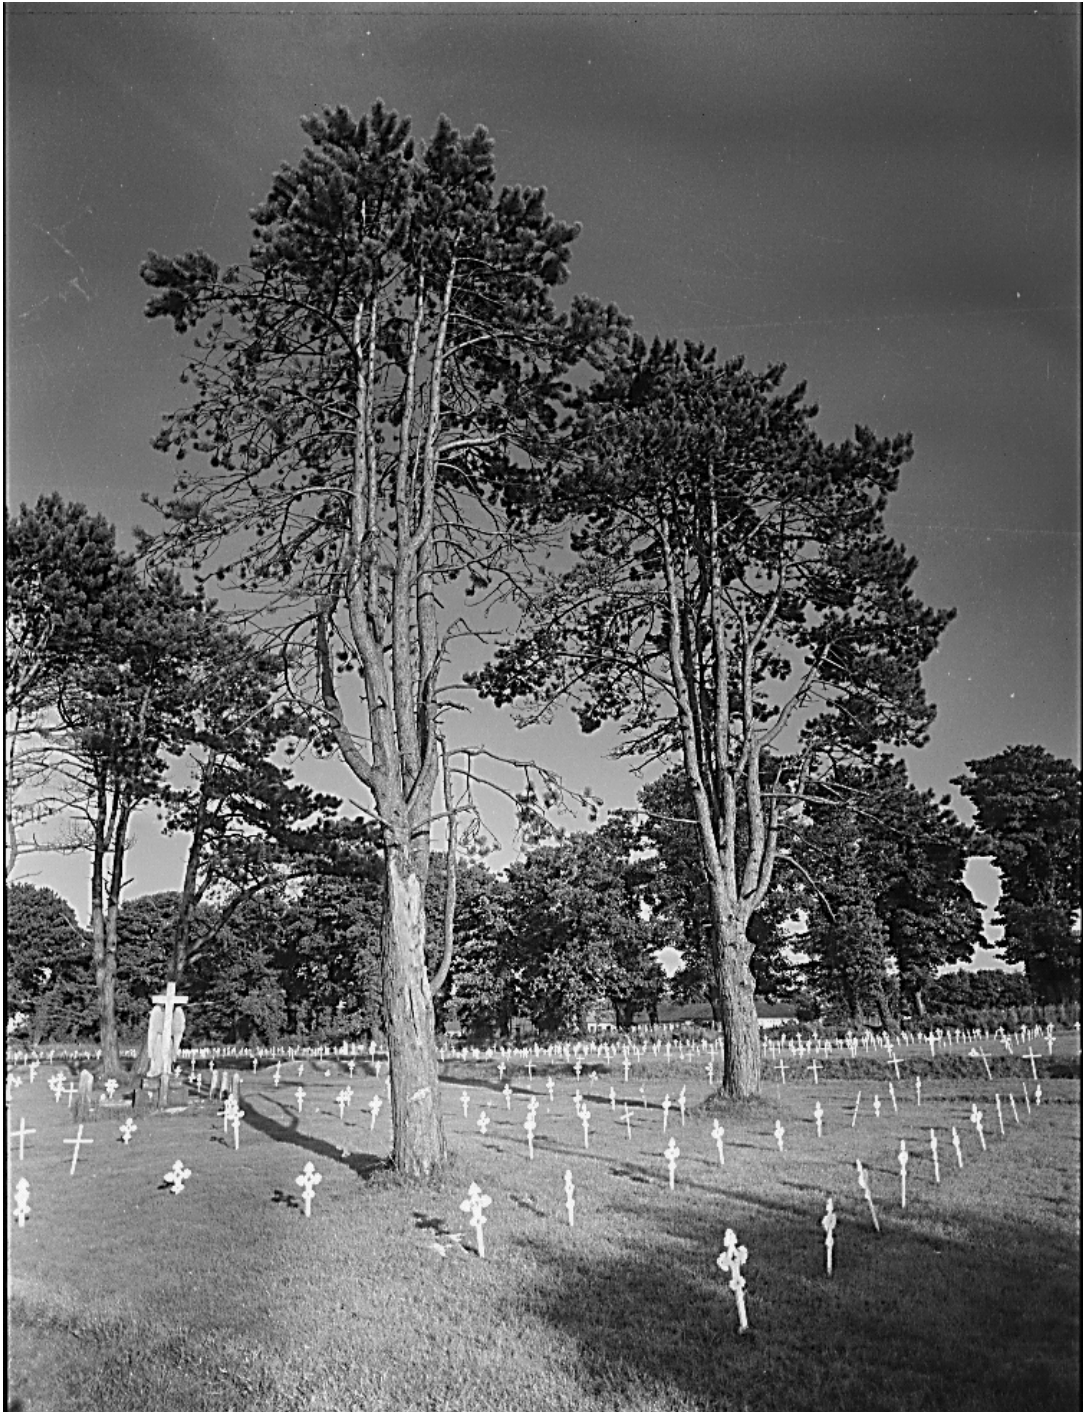
- Photograph taken in late afternoon from NW corner of Plot 4.
- Three of the Austrian Pines in Plot 4 are visible and the rear of the Finegan monument.
- Crosses are tidily arranged in Plots 4, 6, 8 and 10. Further to the E they also seem to be tidily arranged in Plot 9.
- Plot 6 crosses are S facing and a high soil ridge seems to run the length of the plot.
- Plot 4 is tidily arranged with crosses in approx 1m intervals. Eleven crosses are visible in the Wmost row while 10 crosses are standing in row 2.
- Six crosses are standing in row 3, which is disrupted by two of the Austrian pines.
- The Finegan monument is visible from behind and there is a view of what appears to be a pillar 574 and chain railing. The pillars are relatively high. This monument appears to be of a type commonly erected in the early 20th century – indicating it was erected soon after Eleanor Finegan died in 1908.

Plate 35: Photograph from 1970s in NW corner

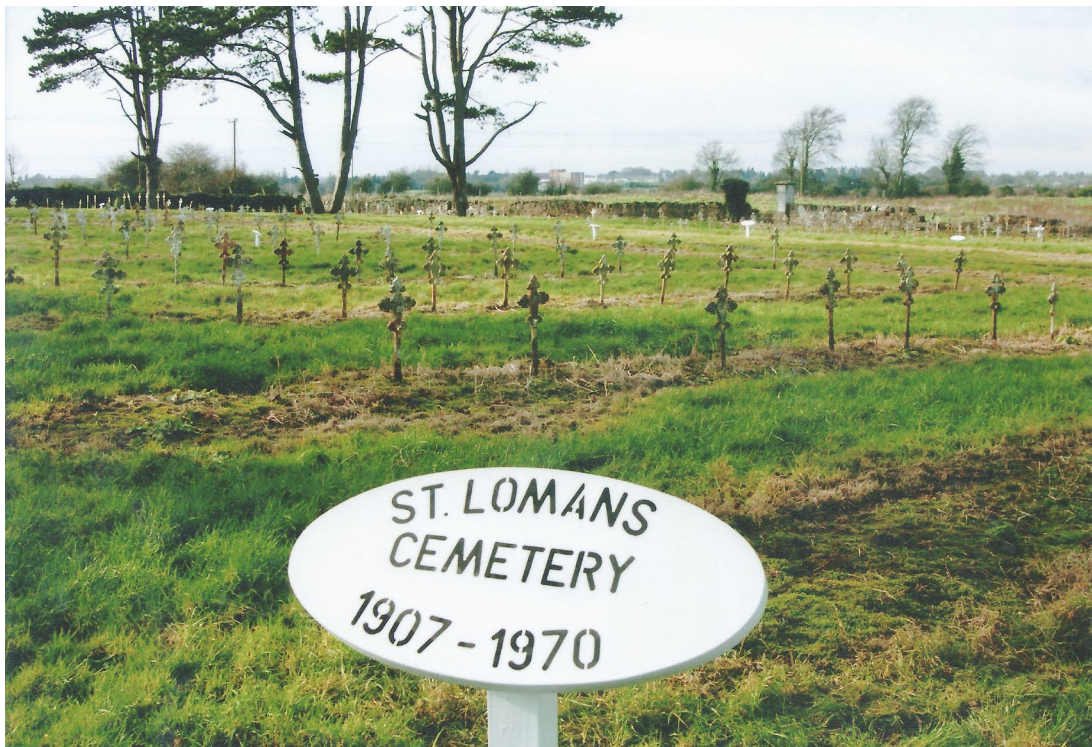
Photograph 4

Plate 36: Photograph from 1990s in SE corner

- One of the Plot 4 Austrian pines cannot be seen and has presumably fallen or been felled.
- Clear and tidy rows of crosses are present in Plot 9. The crosses have not been painted white for some time. The ground vegetation is being managed by a mixture of mowing and weed killer is being sprayed along the rows of iron crosses.

- No numbers can be seen on any of the iron crosses.
