Conservation and Management Plan

Reilig Ospidéal Naomh Lomáin

St Loman's Cemetery

Mullingar Co. Westmeath

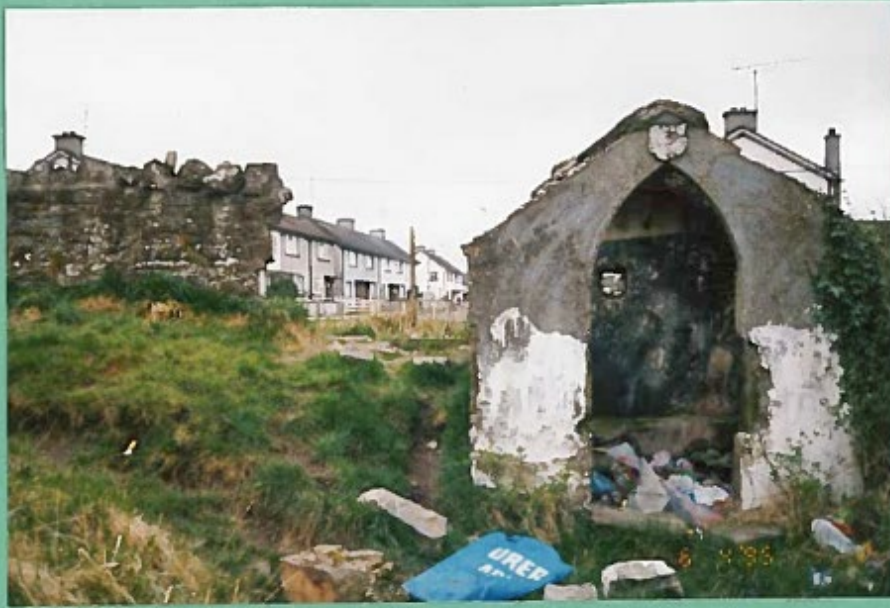
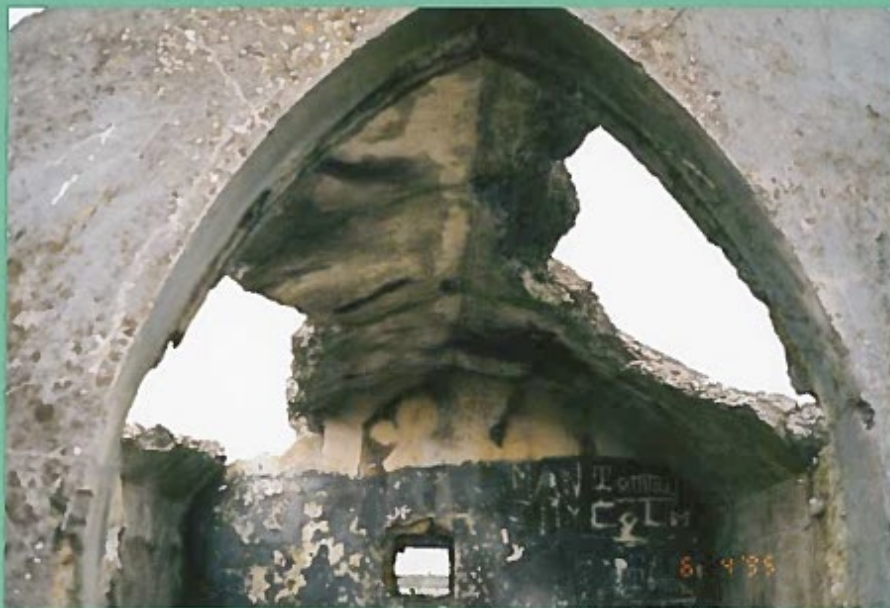
Plate 37: Photograph of mortuary in 1990s

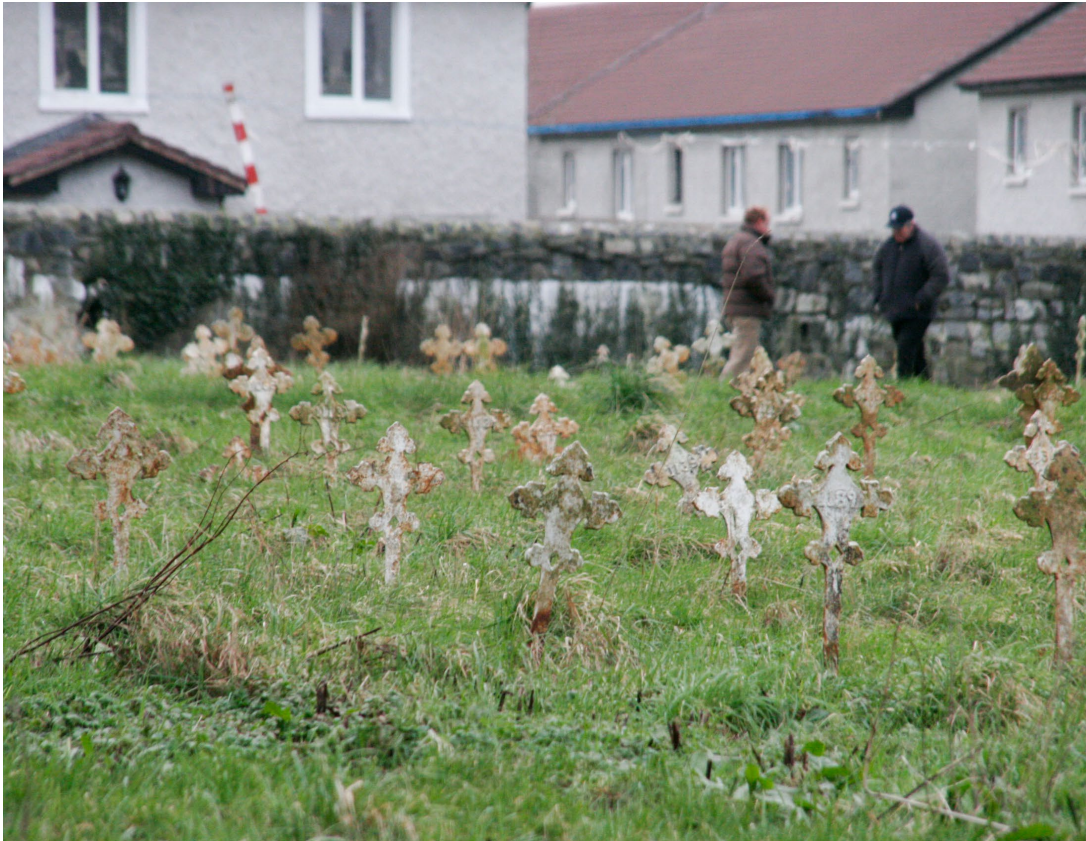
Plate 38: Photograph of crosses in Plot 10.

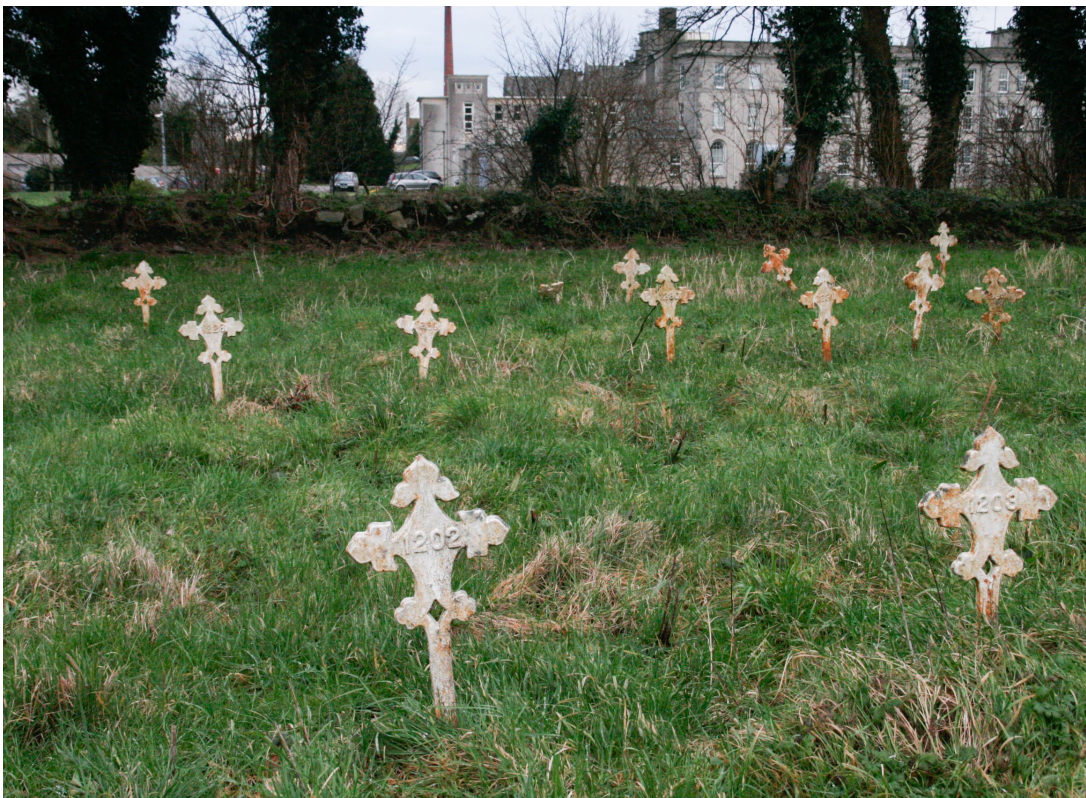
Plate 39: Photograph of crosses in Plot 9

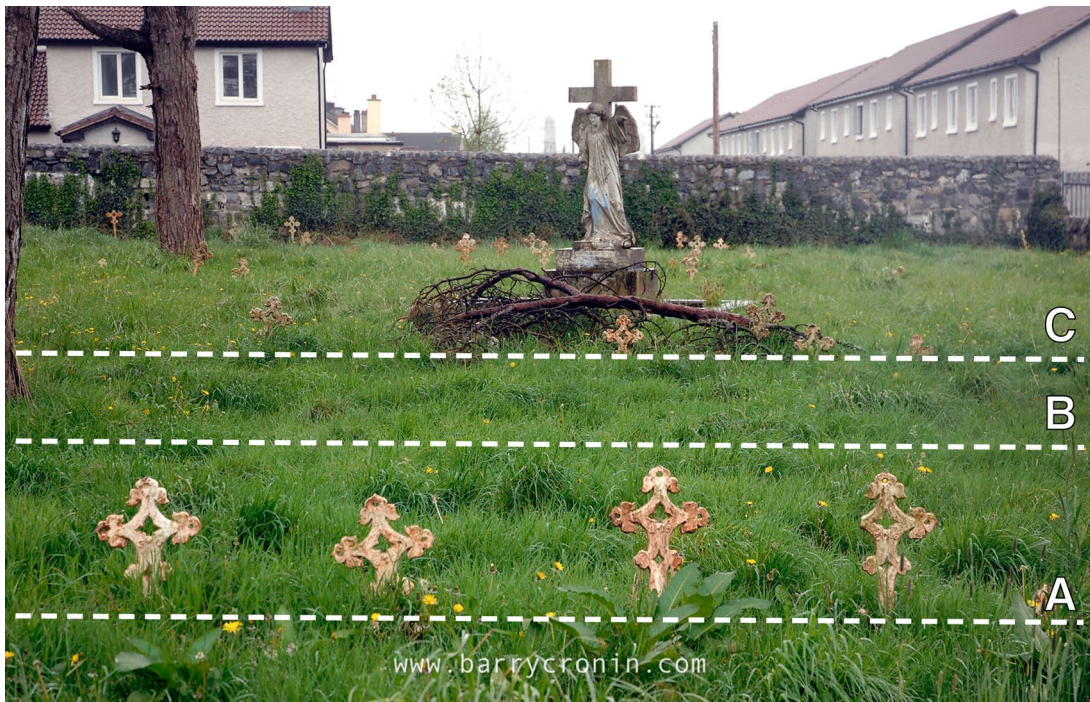
Plate 40: Photograph of crosses in Plot 3
