CASE STUDY Newcastle Community hospital, Wicklow

€40,000 water bill savings through leak detection

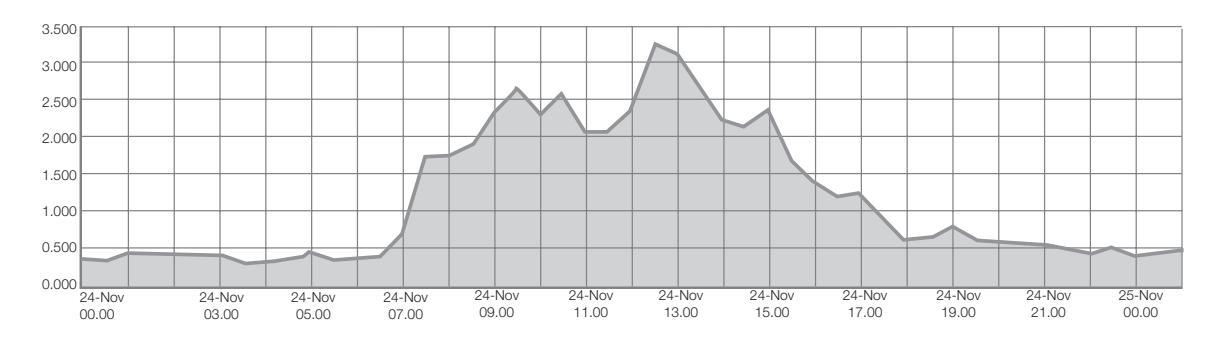
In 2011, as part of a collaborative project between the HSE and Wicklow County Council, water use at Newcastle Hospital was examined using an online system that was available for the sites mains water meter. Initially it was found that the daily consumption for the site was ~80m³. While the consumption didn't vary hugely from day to day it was noted that there was a very high flow rate during the night time. Since the hospital essentially caters for long term care and day-time activity, the flow rates at night were much higher than they should have been. It was estimated that there was a daily loss of water of 40m³ and this was costing ~€125 a day.

Based on these findings, a reparation plan was put in place. This work was carried out during 2011 and cost in the region of \in 13,000. By the time this was finished, the daily consumption of water had dropped from 80m³ to 40m³. It is estimated that, based on a total cost of \in 3.05 per m³, a 1 m³ loss of water equates to ~ \in 1,000 annually. So this water saving work, which cost \in 20,000 in terms of the initial detection work and subsequent repair, has resulted in annual savings of ~ \in 40,000 since 2012.
