# Dementia Inclusive Design Audit

A Dementia Inclusive Audit of key areas within the Primary Care Centre Clonbrusk, Athlone

April 2020

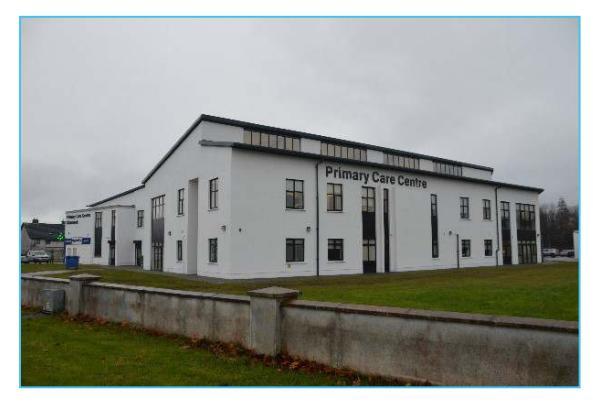
Figure 1. View as you approach, entrance not visible from the road.

I. Thought should be given to providing clear signage to direct visitors, approaching from all direction and by all means of transport to the main entrance. The pedestrian route/path off Arcadia Road has no directional signage to the principle entrance. This should be provided.

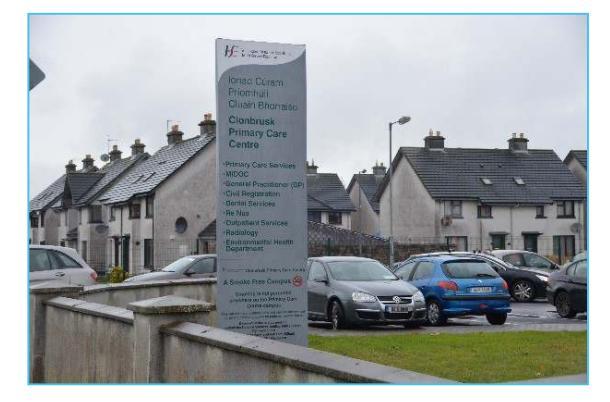
Figure 2. Arrival information.

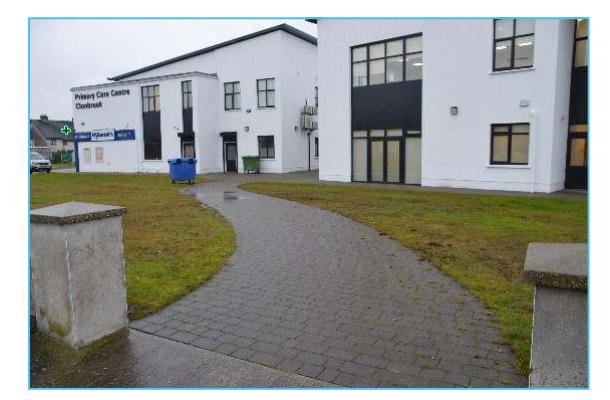
The path at the front of the centre had an area of standing water on the day of the audit. This could be a perceived as a slip hazard or be an actual slip hazard in cold weather.

A few small areas of path had visible growth of weeds and grass beginning to show through. This should be checked and remedied as the integrity of the brick interlocking paving will be damaged and the organic material on the footpath may present a slip and trip hazard for some users.

Figure 3. Standing water, and weeds.

- I. Continue to maintain the pedestrian routes to a high standard and remove grass or weed growth from the footpath areas as and when needed.
- II. Provide contrasting strips on signposts and lampposts to enhance visibility.
- III. Review the use of blister paving and install at dropped kerbs that lead into the line of moving vehicles.
- IV. Provide accessible seating adjacent to access route footpaths leading to entrances.
- V. Inspect areas of path with standing water and carry out remedial work as required.

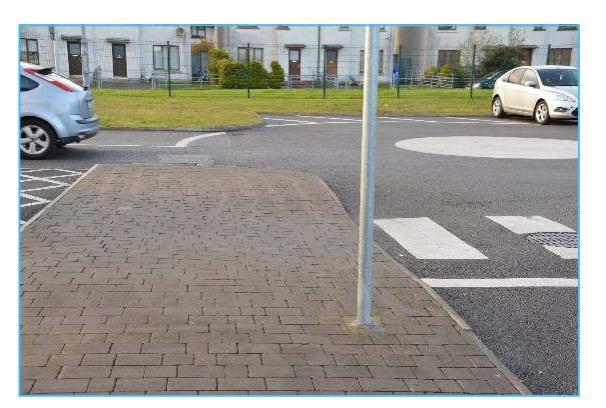
Figure 4. No blister paving at crossing point.

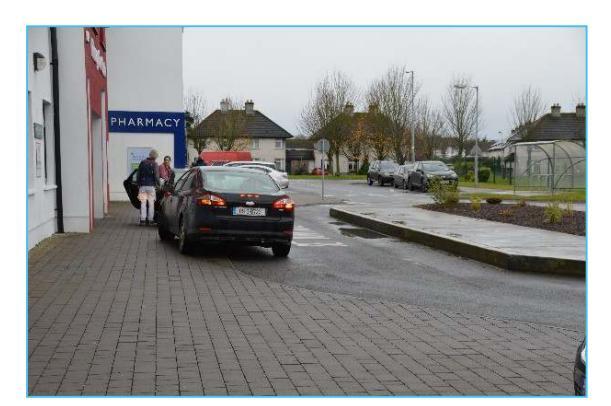
Cars mounting the footpath are a hazard to pedestrians using the access route. They cause an obstruction and block free and unimpeded access to the main entrance. Footpaths are not designed to take vehicular traffic and ultimately kerbs and footpaths surfaces will be damaged.

Figure 5. Cars parked on the footpath and obstructing the entrance.

- I. Protect the pedestrian access routes by installing bollards to prevent cars from mounting the footpaths.
- II. Provide weather protection for people using the set down area.
- **III.** Assess the set down area layout to see if the design can be improved and if it is adequate for the number of visitors who need to use it.
- IV. Providing a suitable safe seating area in the entrance hall would reduce the time some drivers need to spend parked in this zone.

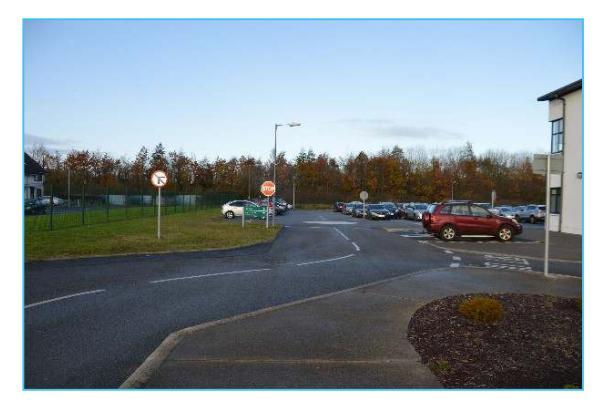
Figure 6. No right turn, roundabout ahead.

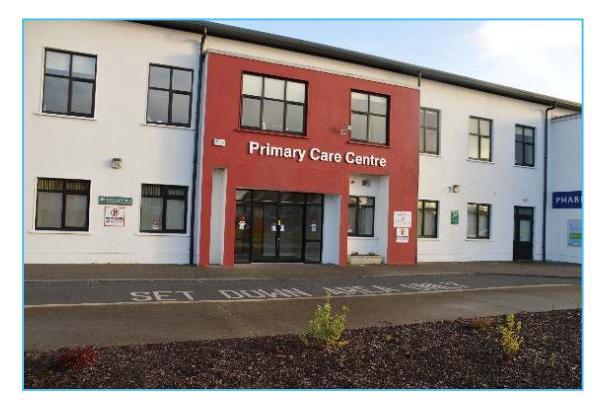
Figure 7. Main entrance is prominent on the west elevation. If doors contrasted with surrounding fenestration it would improve visual access.

- I. The large spacious entrance hall could accommodate a reception desk and accessible seating. This would assist people dropping off service users and provide immediate access to help and information on entering the building.
- II. GP practices should be visually highlighted within the entrance area. This would reduce the number of unnecessary journeys to reception.
- III. Signage should be reviewed and replaced or augmented with new inclusive signage see section 4.9 below for further detail.
- IV. Flooring and entrance matting, when replaced, should be designed to meet inclusive design standards, reducing visual clutter and LRV contrast differential between materials

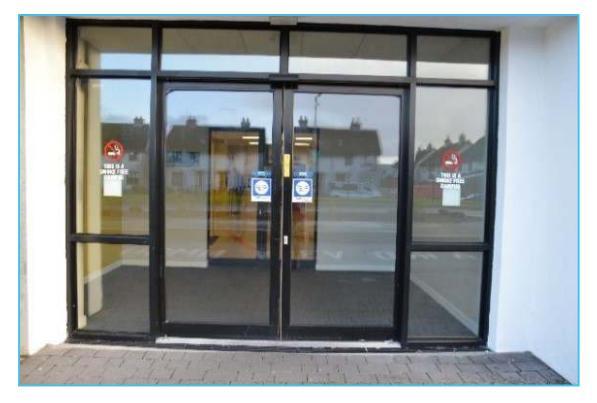
Figure 9. Threshold contrast, illusion of a step.

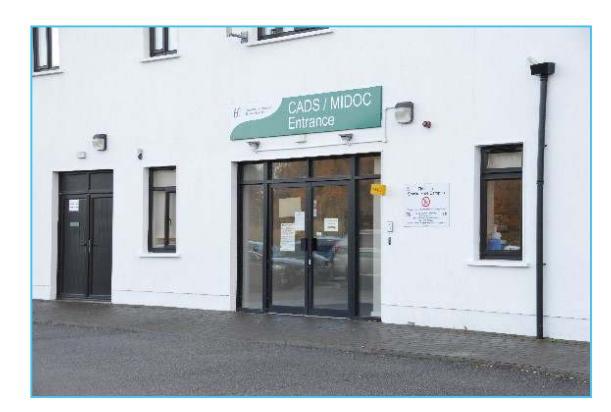
Figure 8. CADS and MIDOC entrance at rear of building. If doors contrasted with surrounding fenestration it would improve visual access.

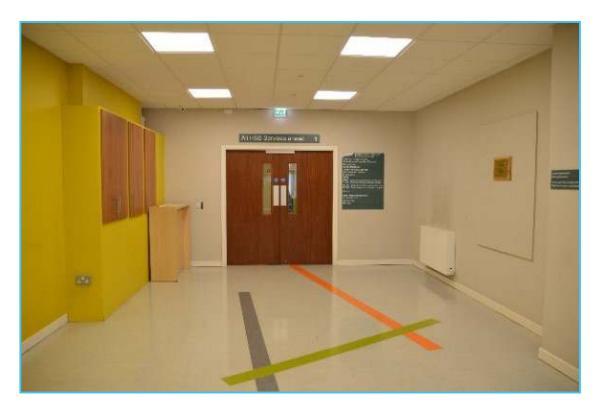
Figure 10. Entrance hall, no visual access to reception and no seating.

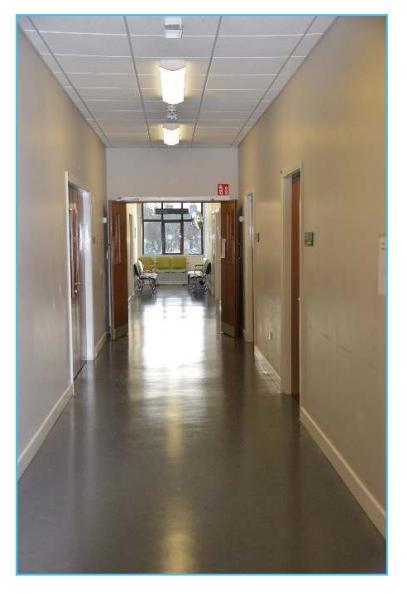
Floors are maintained with a high gloss finish. This is a practice that should be ceased. The reflection and glare create a difficult environment for people living with cognitive and sensory impairments. Floors with a gloss finish can be perceived as being slippery which could cause a person to change their gait which can lead to trips and falls. The glare can be blinding, and reflection can be misinterpreted. If the surface polish is removed the glare will be greatly reduced.

Figure 11. Glare can cause anxiety and fear of falling

- III. The gloss floors polish should be removed to reduce glare and reflection. As and when floors are replaced during maintenance cycles it is recommended unnecessary patterns are removed and colour and tonal differences between areas are eliminated. This will improve inclusive access.

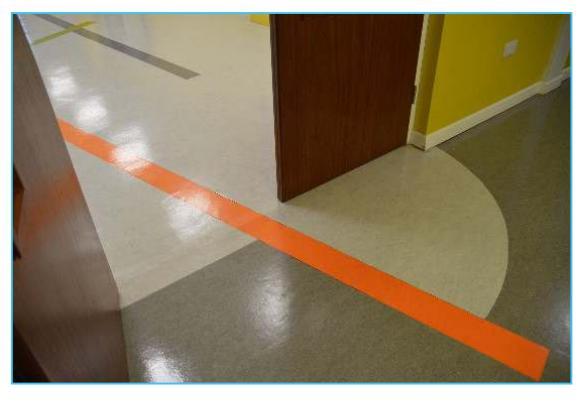
Figure 12. Contrasting floor pattern, in entrance and reception areas adds unnecessary visual clutter, could be misinterpreted as obstacles and changes in levels

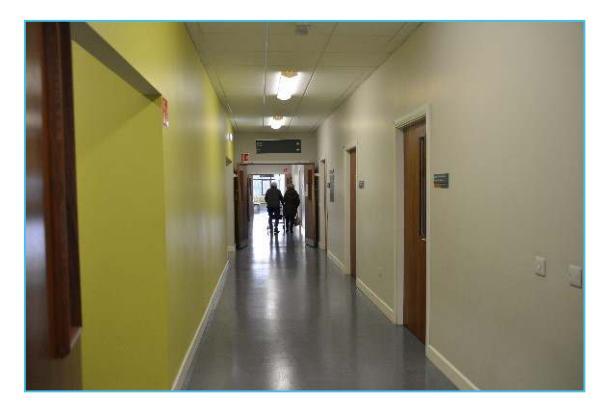
Figure 13. High gloss floor polish, excessive glare is disabling

Upgrading toilet facilities to provide the required contrast and ambulant disabled provision to comply with Part M, Access and Use, would improve facilities and safety for all service users. Removing the high gloss floor polish would greatly reduce the glare in the circulation areas and is highly recommended.

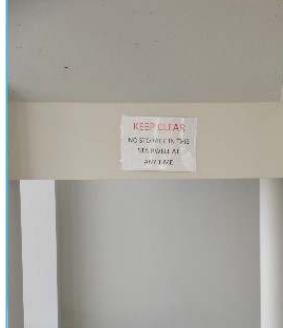
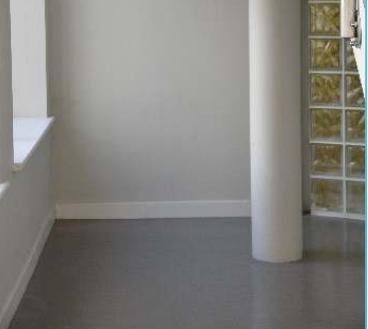
Figure 14. Low soffit under stairs ground floor

- I. Install a continuous barrier to prevent a person colliding with the underside of the stair soffit in the main reception hall.
- II. Investigate replacing glass panels on stairs and landing with non-reflective and opaque panels to help support spatial orientation and reduce glare and reflections.
- III. If space permits (means of escape requirements cannot be compromised, escape widths) the emergency escape stairs should be upgraded to improve safety and visual access. Signage should be moved from below the light fitting on first floor landing and placed in a suitable location.

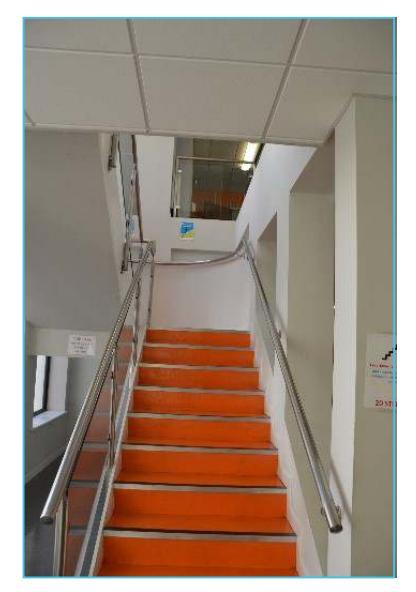
Figure 16. Stairs reflection in glass guarding and open-ended handrails.

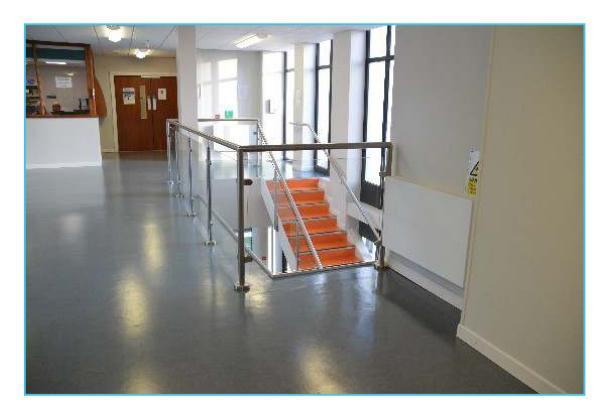
Figure 15. Glass guarding offers lack of visual clarity

- For dementia inclusive environments a glass guarding is not recommended. The glare and reflections add to the visual complexity of the environment and may be distracting and cause confusion.

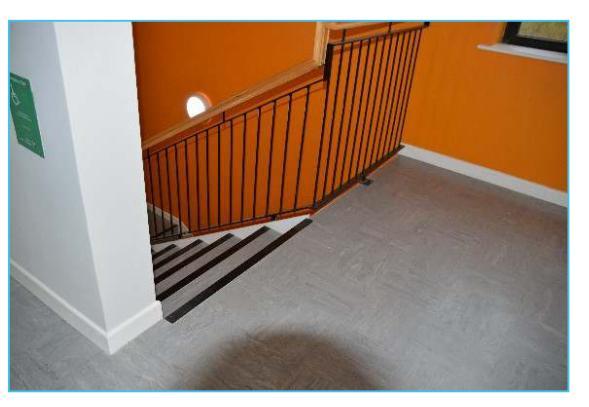
There is no prior warning that you are on the step edge. Handrails are provided on one side only. Signage on the first-floor landing is placed directly below a light fitting. Dementia can result in a reduced ability to adjust to light conditions and tolerate glare. This placement is not ideal.

Figure 17. Unprotected top step, no handrail to warn of change in level.

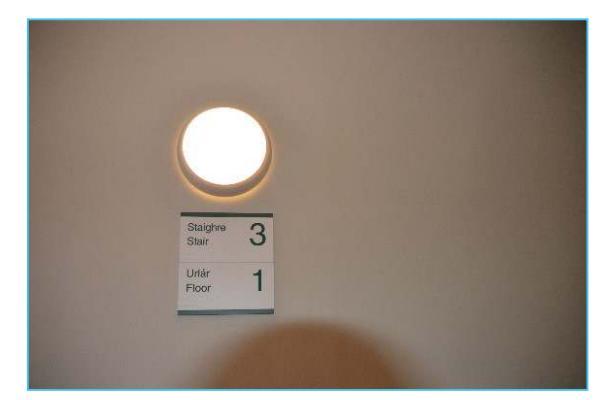
Figure 18. Light fitting directly above signage, glare

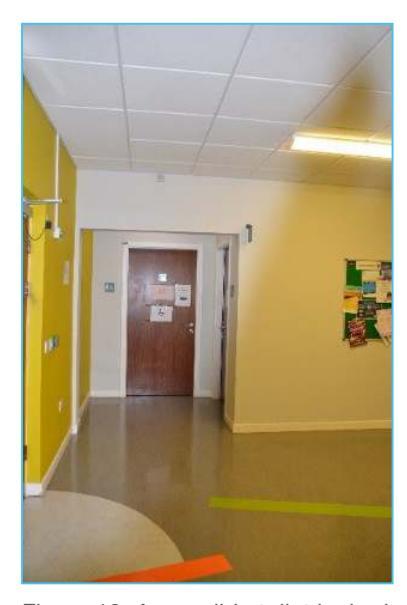
Figure 19. Accessible toilet locked and poor signage to all toilet facilities

- I. Toilet facilities must be clearly signposted so they can be found with ease and without having to request assistance.
- II. Ensure the grab rails and fittings in all the toilet facilities have the required visual contrast with the background wall against which they are viewed.

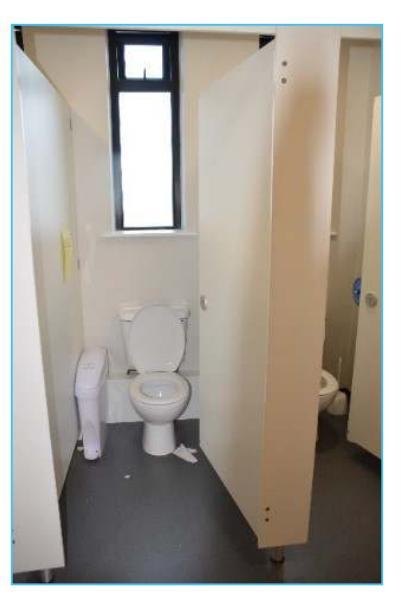
Figure 20. No ambulant disabled grab rails and lack of contrast

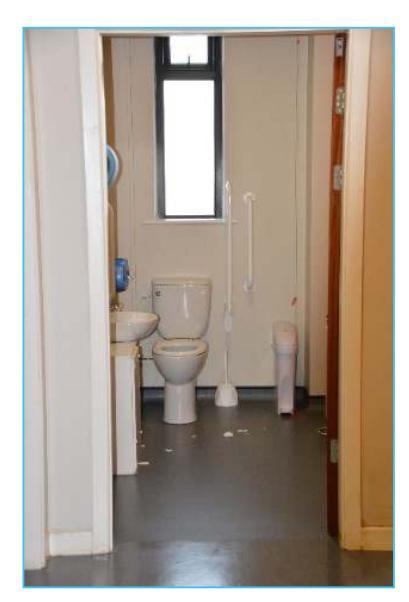
Figure 21. Lack of visual contrast in accessible toilets

- V. Toilet seats should be replaced to give visual contrast with the WC pan and cistern. Please note red is not a recommended colour option. Red is widely recommended by sanitary suppliers for use in dementia friendly facilities however a grey, blue or charcoal colour would be a more acceptable alternative.

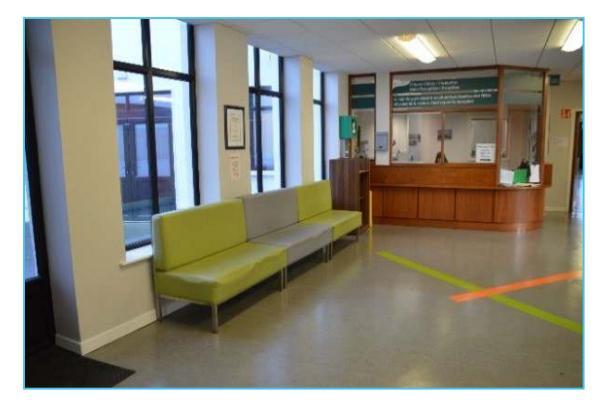
Figure 22. Seating with arms supports independent use.

- I. Accessible seating should be provided in the entrance area.
- II. Waiting areas should have seating with a variety of seat heights and with arm rests. Space should be provided for wheelchairs users in waiting areas.
- III. To improve visual access and clarity seating should contrast visually with its surrounding and against the floor on which it sits.

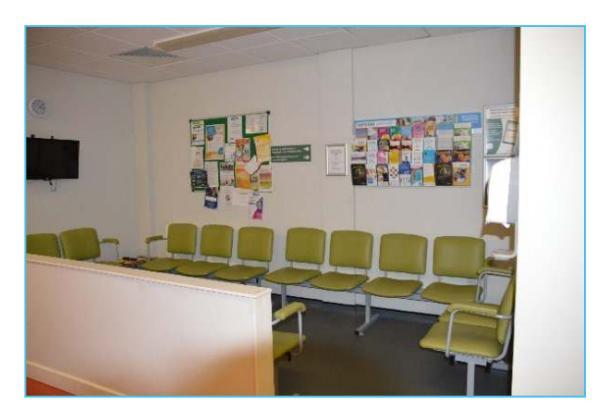
Figure 23. Provide space for wheelchairs and seats of different heights

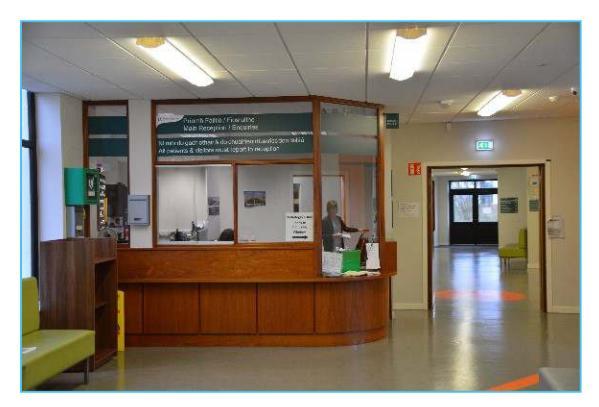
Figure 24. Signage above line of vision and too discreet

- I. Clonbrusk PPC should commission a review and assessment of the existing signage and commission a new dementia inclusive signage scheme and wayfinding strategy.
- II. Remove all unnecessary advertising and information notices. Consider necessity, placement and management of all information boards to reduce visual clutter.
- **III.** Regular clearing and maintenance of notice boards and information displays is necessary to ensure that they remain clearly legible and up to date.
- IV. Signage when provided must be placed and maintained in a clear, obstructed and uncluttered environment.

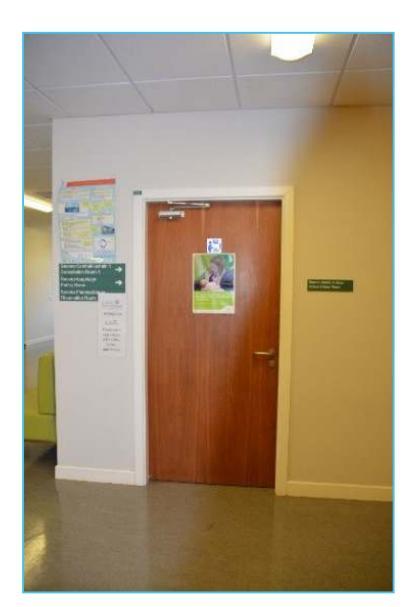
Figure 26. Visual clutter is distracting and overwhelming.

Some recommendations can be actioned immediately and will incur no cost. Removing unnecessary posters and managing notice boards would result in an immediate reduction in visual clutter. Seating removed from waiting areas to make space for wheelchair users could be placed on corridors or in the entrance hall.

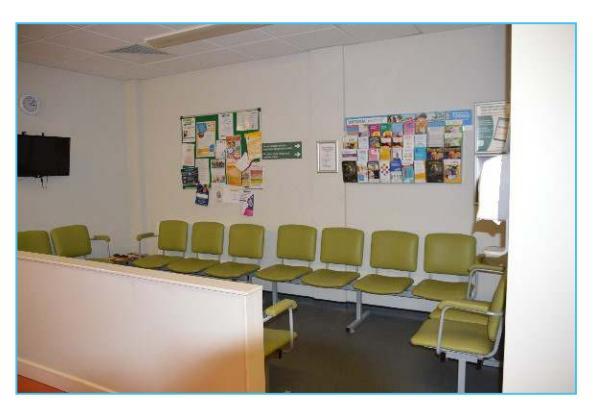
Figure 25. Signage surrounded in visual clutter

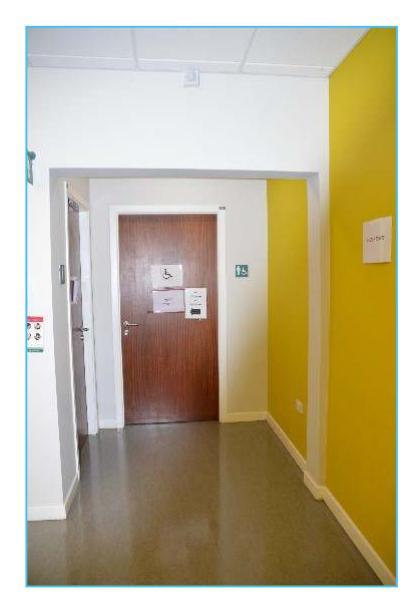
Figure27. Visual clutter, original signage not adequate.

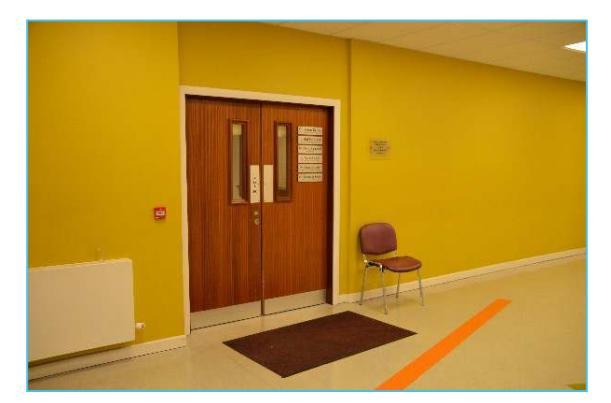
Figure 28. Signage not prominent, requires more visual impact.
